SALTFORD BRASS BATTERY MILL
SALTFORD
AVON

A CONSULTATIVE REPORT

**SALTFORD BRASS BATTERY MILL
SALTFORD
AVON
NGR: ST 687 670**

Richard K Morriss
MA MSocSc MIFA

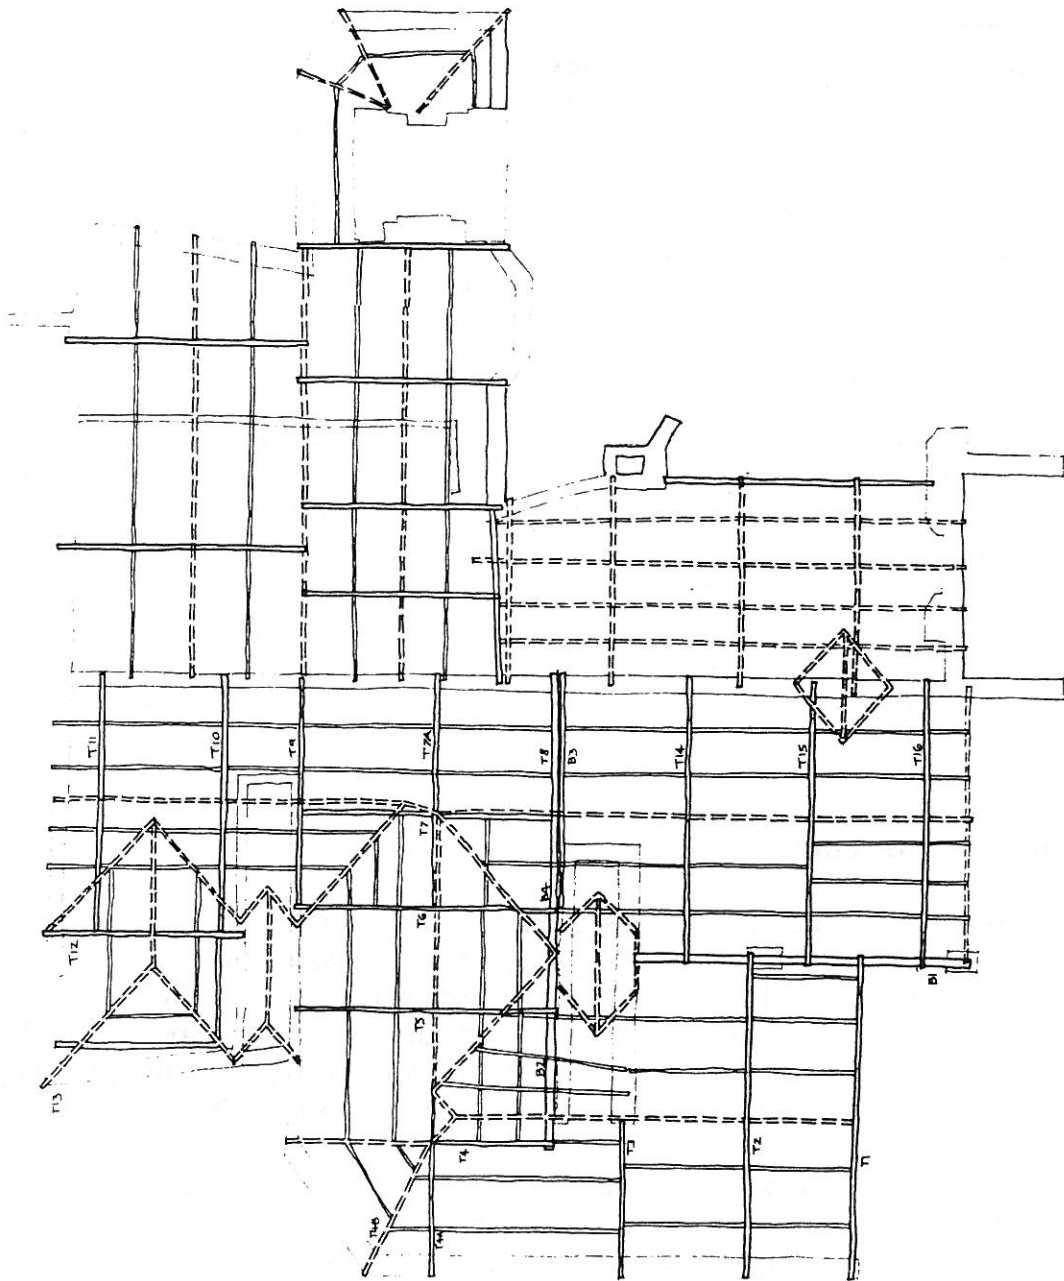
SALTFORD BRASS BATTERY: Roof Structure Plan of Main Complex, with Truss Identification

The similarity of the carpentry of truss types A and B, and the fact that they share a common valley plate, seems to indicate that they are contemporary - but as the Type A trusses are secondary to the south wall masonry, both roof structures are therefore secondary. The fact that the Type B trusses are made of re-used material, but re-used from a similar type of truss, is one that needs to be investigated.

There are, in the complex roof structure, at least five basic types of truss - excluding the 20th century trusses over the squash court area and the rebuilt trusses by the annealing furnace. All but one type of these trusses are variations of king-posts. The truss designation below is also used in a simplistic way to identify the various different roofs.

The Type A trusses (labelled T1 and T2 on the plans) are the only ones that appear to have been little altered. They are simple king-post trusses with tie-beam, king-post diminishing and tapered above the junctions of the single pair of braces, flared post-head, and principal rafters supporting two pairs of interrupted purlins. The feet of the king-posts are tenoned into a housed mortise in the tie. The same basic style of carpentry, and of carpentry marks, exists in the half-truss to the west, T3, indicating that this is contemporary with the rest of this section of roof. The roof itself respects the later phase of the south elevation (S3), indicating that it is secondary to the earlier masonry. There are no wall-plates.

The roof structure has clearly been subject to considerable amounts of repair and alterations over the years. It is suggested that the king-post trusses are earlier than the 'A' frame type, and that most of the changes made to the king-posts was carried out after they were in place.

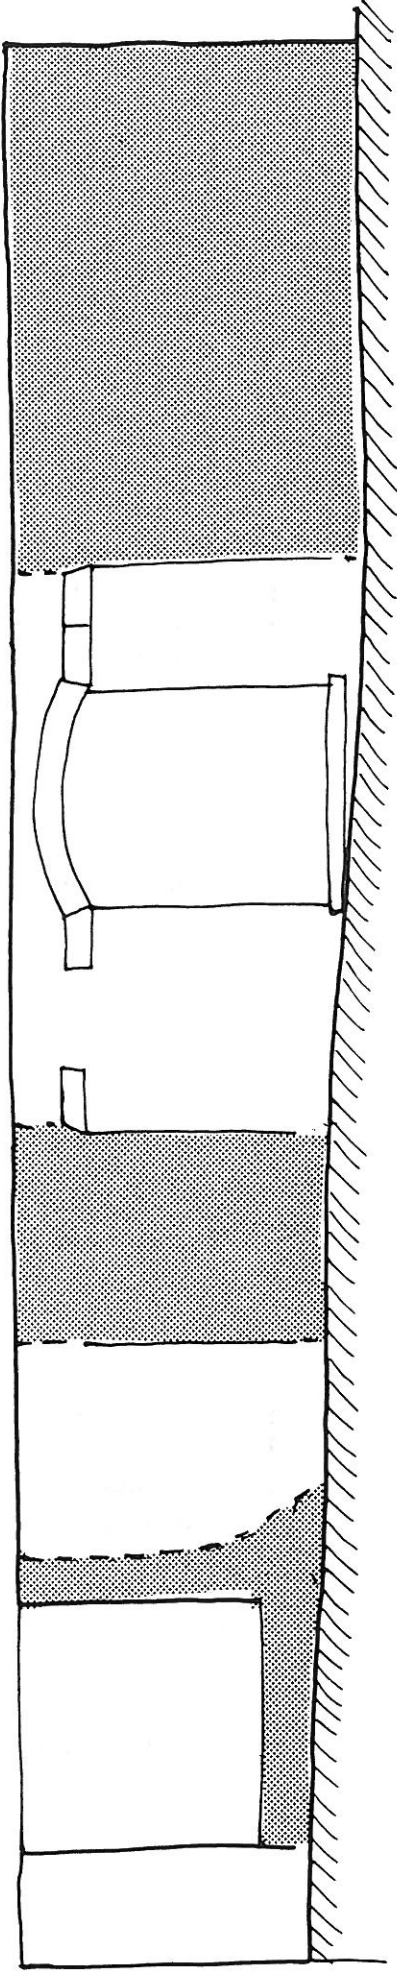
SALTFORD BRASS BATTERY: Outline Survey of South Elevation (S3)

The local rubblestone on this elevation is loosely coursed and there are ashlar quoins on the angles. The segmental heads of primary window and door openings are also of ashlar, and there are also copper slag blocks around the westernmost window. The western portion is set back from the rest and is built over part of the water course network and supported by a wide, shallow, two-centred arch. The opening to the wheelpit (No.2) containing the restored waterwheel has a segmental ashlar head with further ashlar courses above, and ashlar jambs. The straight breaks in the masonry at this point seem to indicate that this opening is inserted. If this is so, then as the ashlar wall around much of the wheelpit, the ashlar courses above the head of the opening, and the pantiled mini-gabled roof over the wheelpit are also all secondary to the earlier fabric. This in turn suggests that this general area of roof is also secondary. In addition,

the bridge providing access from the present entrance drive to the area around the external wheelpits (Nos.3 and 4), butts rather unconvincingly against the south elevation itself and is clearly secondary.
