Salford Brass Mill

Watercourse Inspection and Penstock Repair

Survey Report

January 2019

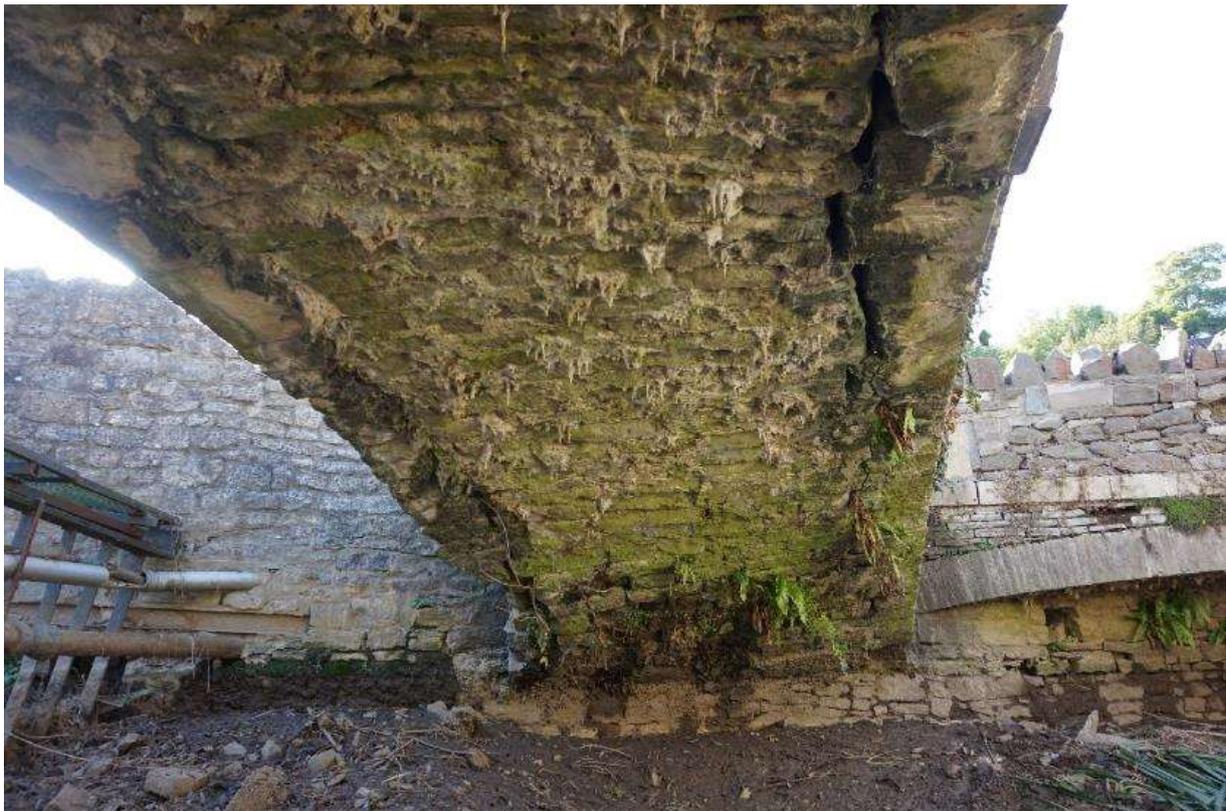
Figure 8 Southern Road Bridge - Watercourse

The bridge structure appears stable and there is no evidence of movement. Two cracks are however visible running east-west along the length of the western arch along the inside of the voussoirs [Figure 8]. The damage is more significant on the northern side of the bridge. The voussoir at the south west springing is also showing signs of freeze-thaw damage to the stone work.

The lime mortar is in reasonable condition but there is evidence of the mortar being washed through the structure resulting in numerous stalactites on the underside of the bridge.

Western span of road bridge showing springing from western abutment and cracking along voussoirs

The damage to the stonework should be monitored and a future programme of repointing developed when the watercourses are next de-watered.

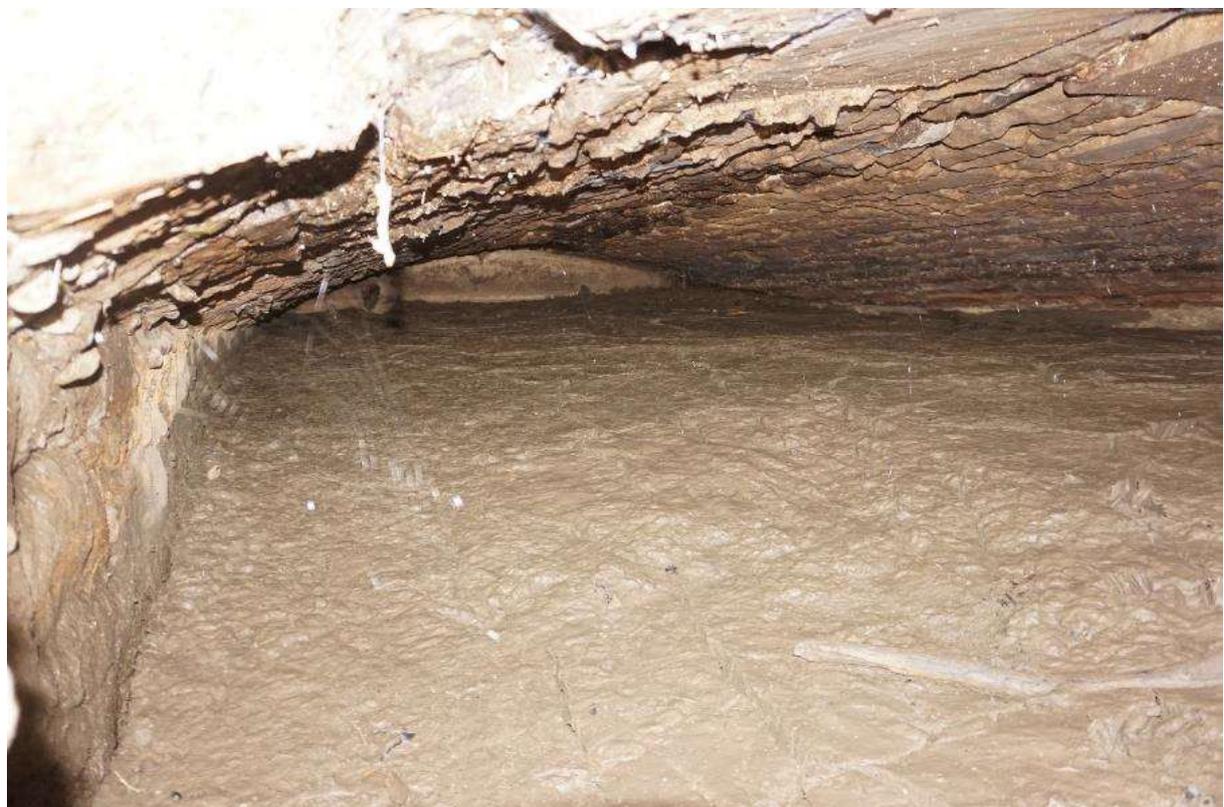
Figure 11 Watercourse W0

Watercourse W0 showing heavy silting and sealing wall

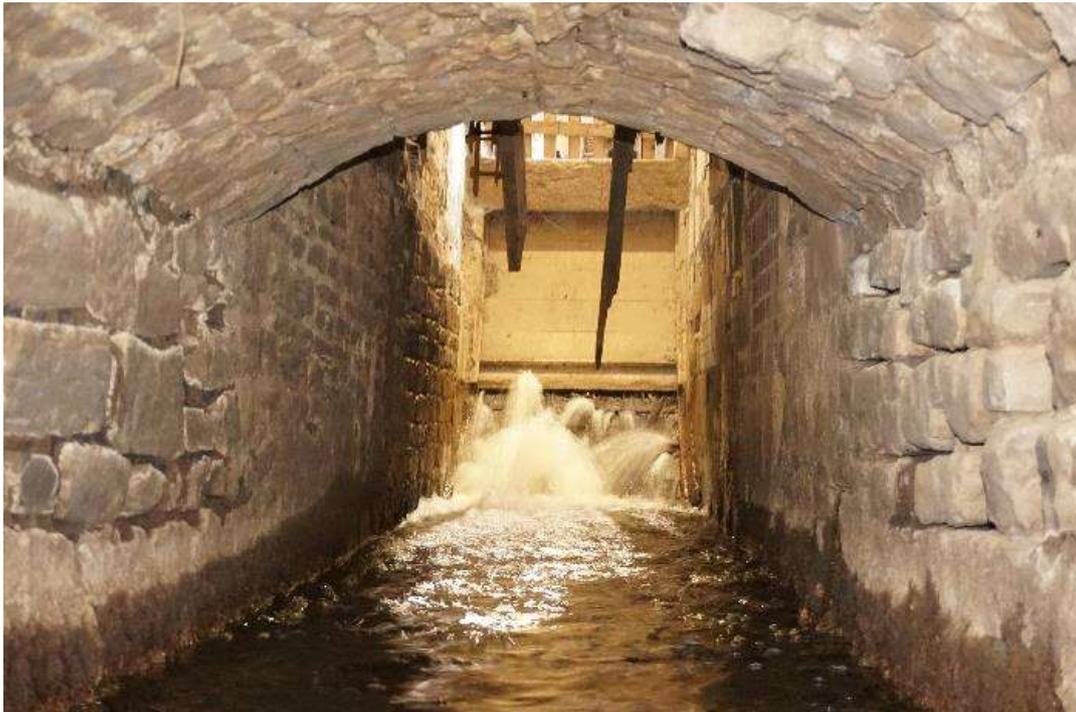
Figure 13 Downstream Watercourse W1 – Upper Reach

Downstream Watercourse W1 - Old Gate – Before Removal showing Leakage

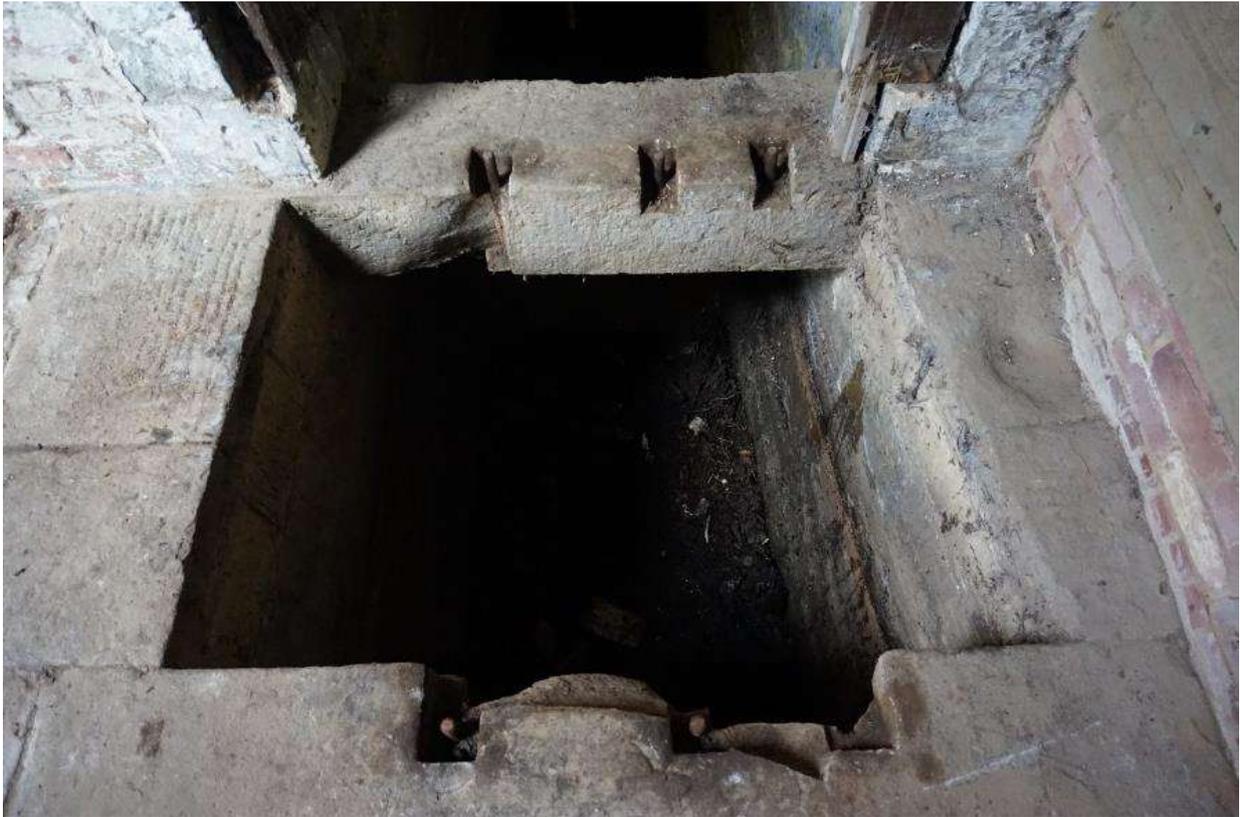
Figure 18 Penstock Gate W1 – Operating Mechanism

The two lintels which support the penstock-gate operating mechanism have been damaged by the swelling of corrosion products around the six mounting bolts. The lintels are not in danger of falling but both lintels are cracked. The action of the corrosion has also caused some of the stone to break way, the damage being most severe on the upstream lintel [Figure 18]. It was judged that the lintels could not continue to take the load of operating

Mounting arrangements of Penstock W1 operating mechanism cut into supporting lintels. Gate and operating mechanism removed. The damage is evident to the lintels caused by corrosion of the securing bolts.

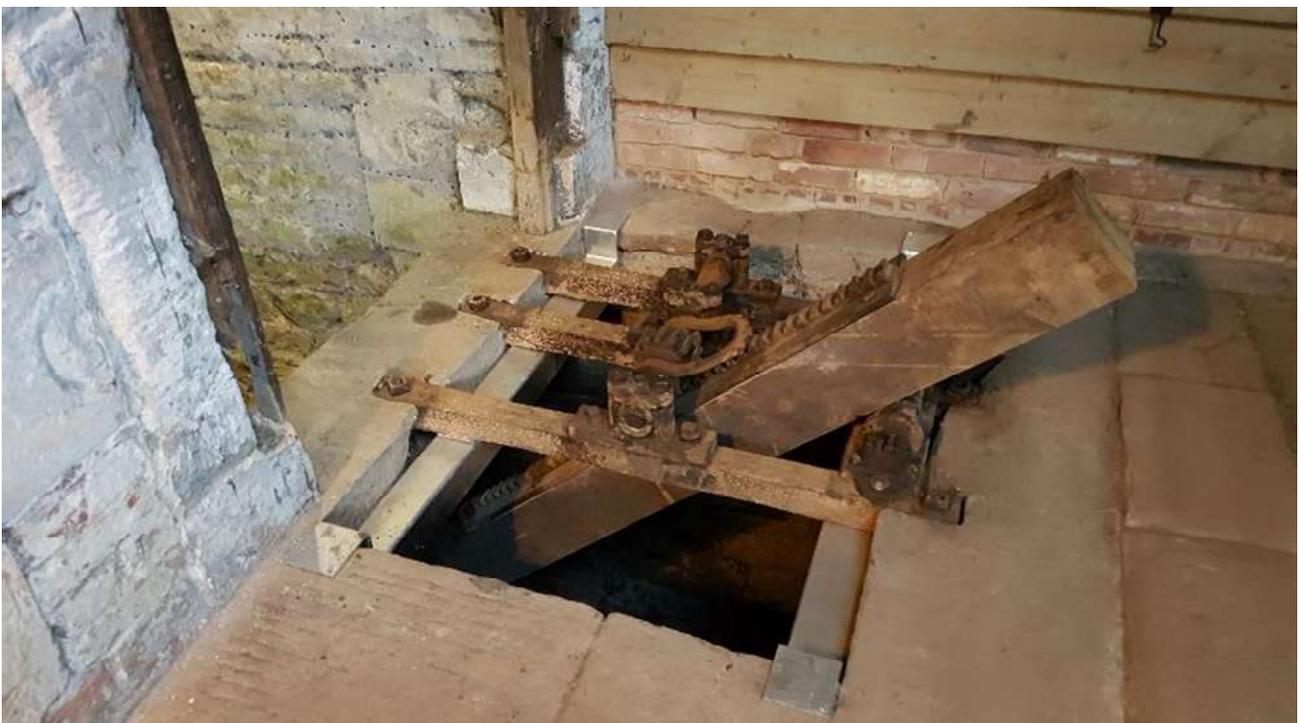
Penstock W1 operating mechanism restored with the new gate and stock in place.
Note fabrications installed to relieve the load on the damaged lintels.

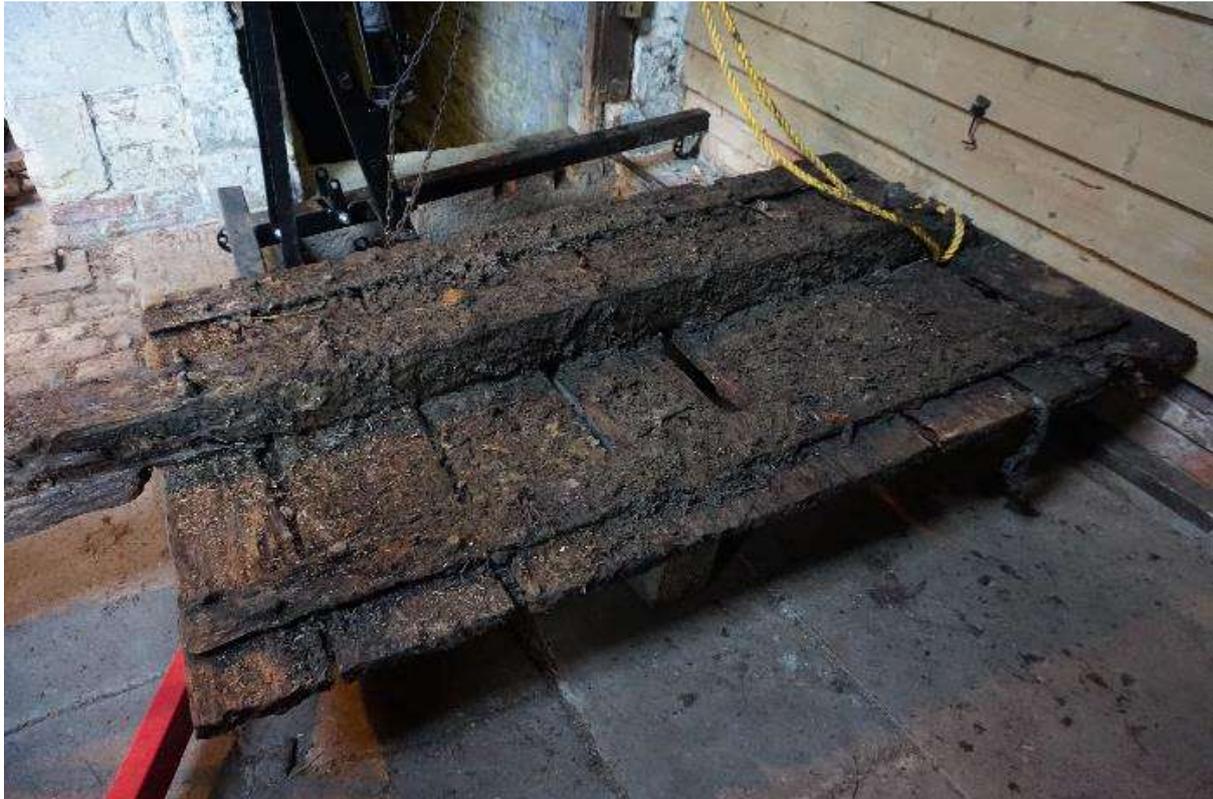
Figure 20 Old Penstock Gate W1

Old Gate – Following Removal

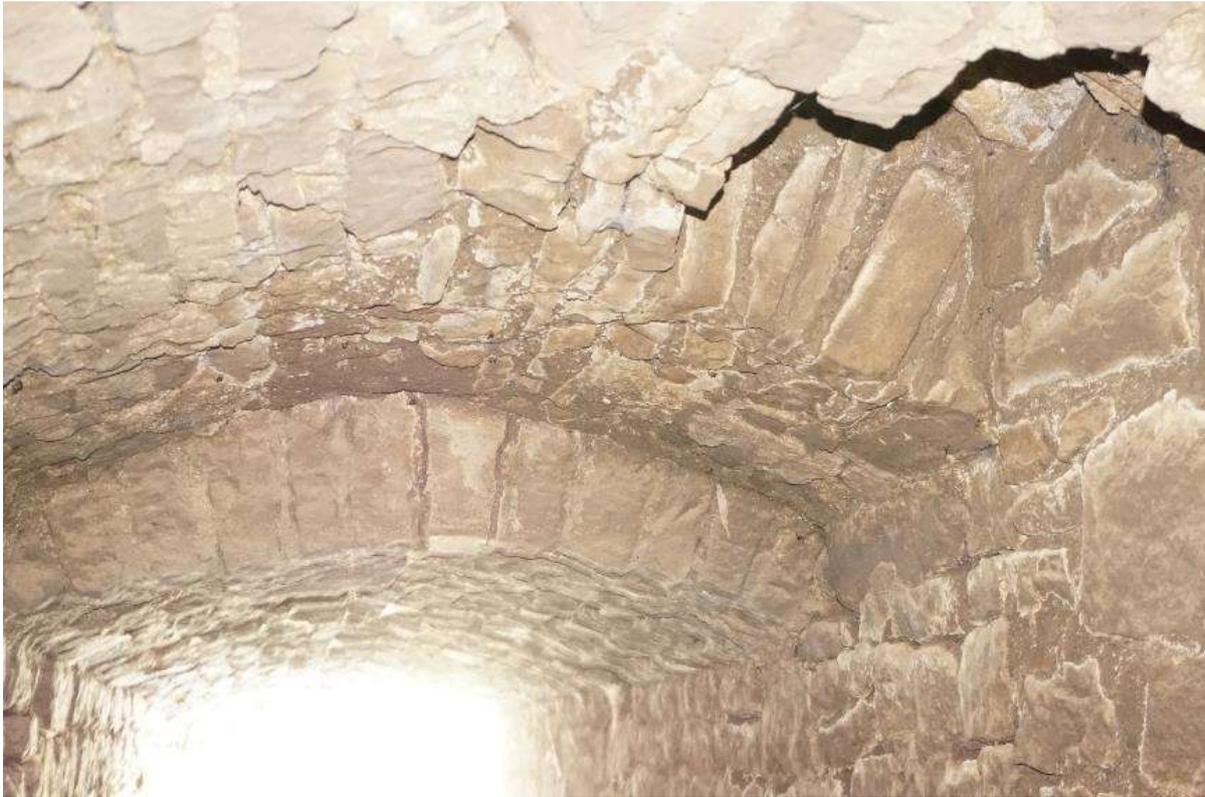
Figure 22 Watercourse W1 – Lower Reach

Discontinuity and opening in upper culvert

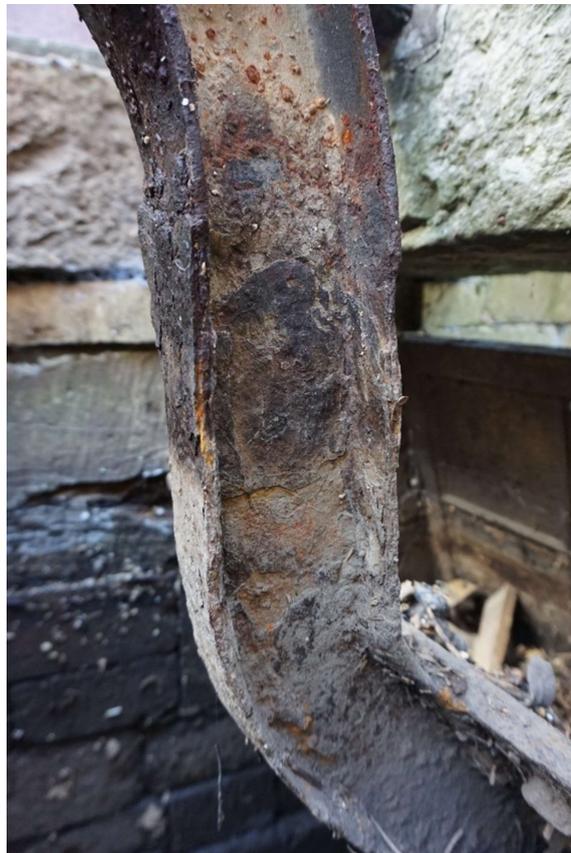
Figure 36 Penstock Gate W4 – Goose-Neck

Damage to goose-neck

The performance of penstock W4 should continue to be monitored, in particular the gooseneck which has experienced significant corrosion damage. If the condition of the gooseneck continues to deteriorate, consideration should be given to replacing the stock, possibly with a timber structure, which may in turn require replacement of the gate.
