# WARMLEY BRASSWORKS

WARMLEY,  
AVON

A SURVEY  
FOR MANAGEMENT

June 1995

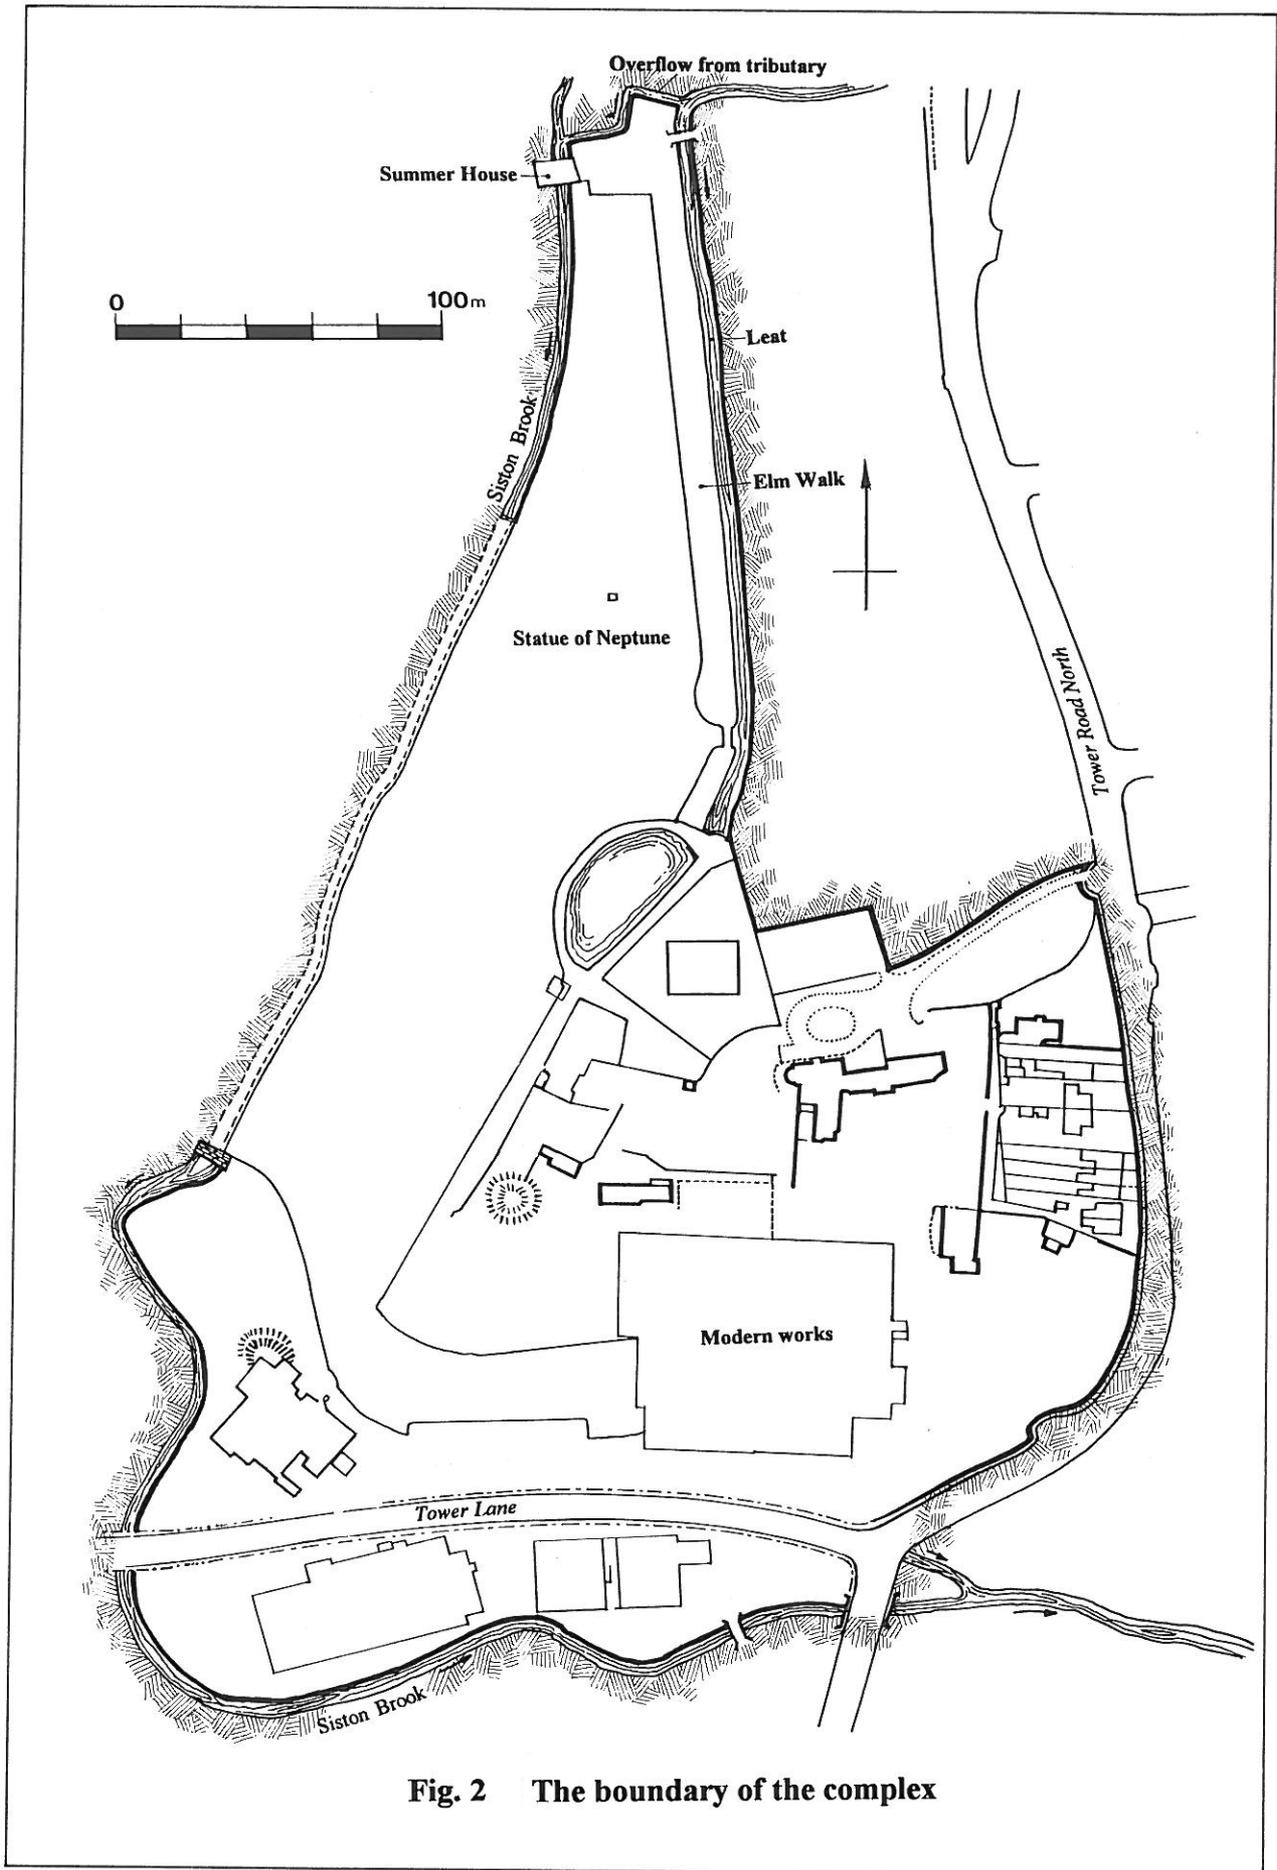
**Fig. 2 The boundary of the complex**

The complex is bounded on the west and south by the Siston Brook starting at, and including the Summer House. On the eastern side the site is bounded by Tower Road North as far as the drive to Warmley House. The car park area to the north of the drive is included and from there the boundary follows the wall of the garden northwards and continues north again to include the east of Elm Walk thus rejoining the Siston Brook.

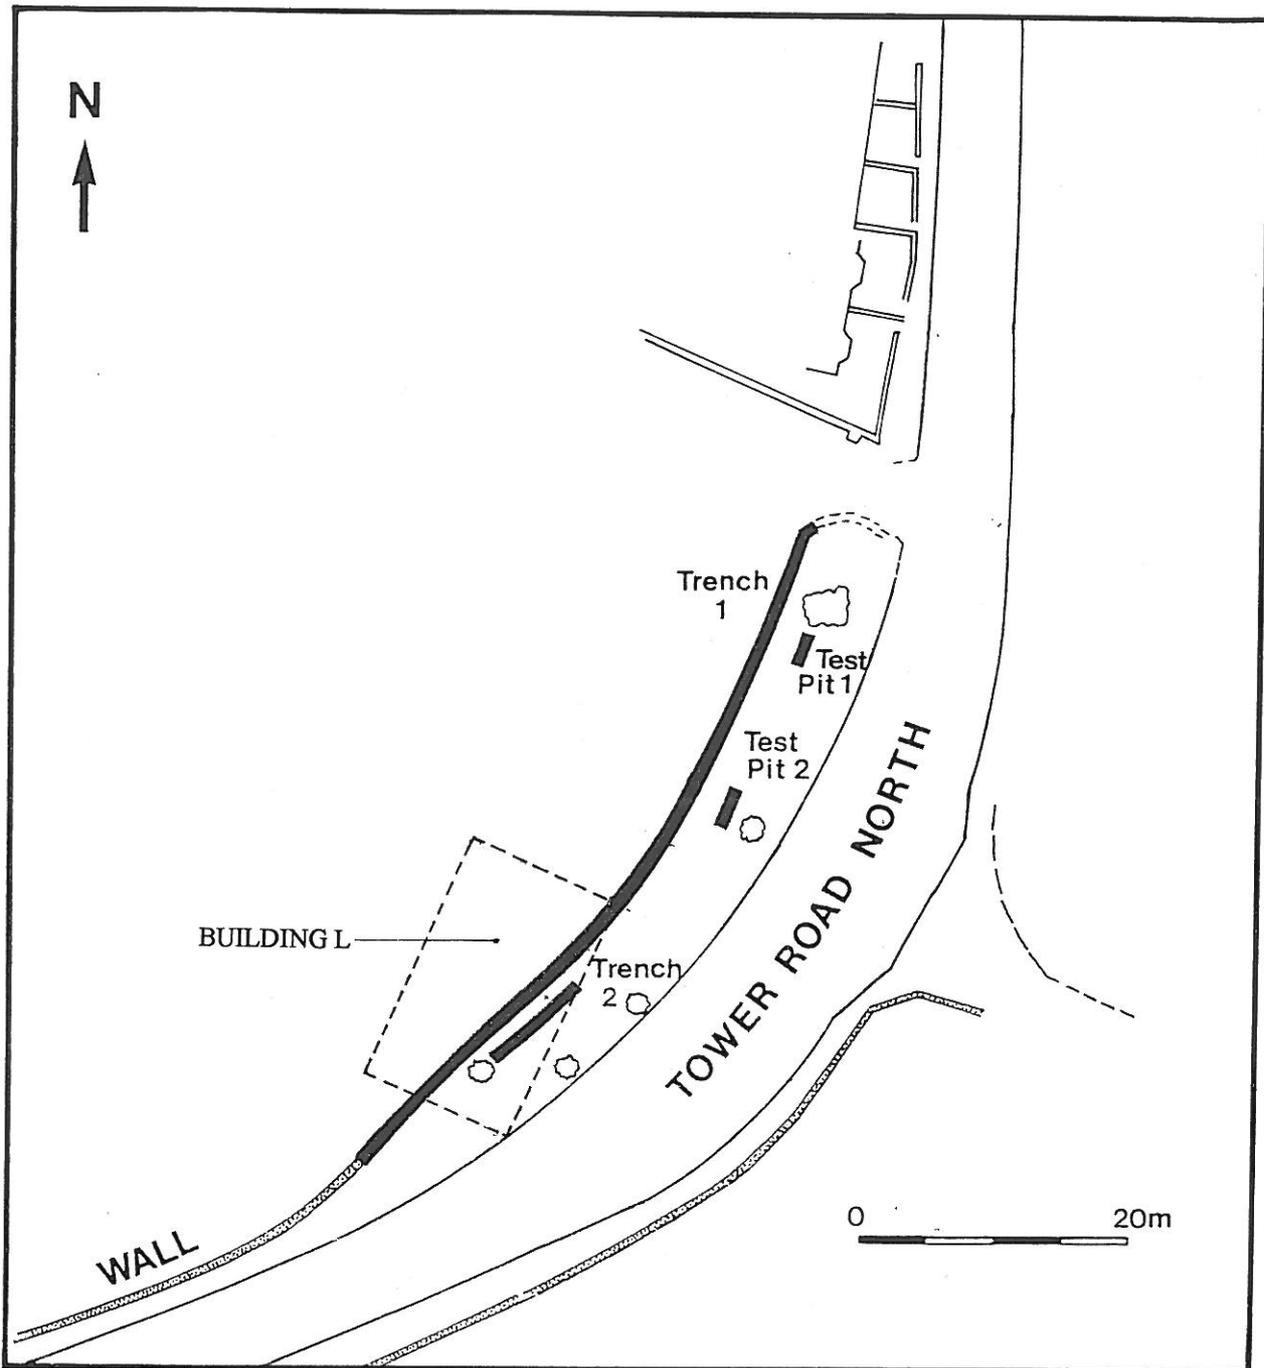
**Fig. 6** The relationship of the excavation to the pre-1841 building 'L' (after Parry, 1994)

Parry found a substantial external wall with a combined thickness of nearly 2m running north-west, south-east. The east side of the area revealed part of another substantial wall with a return. A similarly constructed structure lay 1m to the south with a similar alignment on the west aspect. To the south, three walls were uncovered within an area of approximately 3m. The southernmost of these contained a duct about 1m from surface level. The area between the north, east and south walls was interpreted as being composed of a number of free-standing pillars, originally surmounted with vaulting. The complex would therefore have formed a grid-like layout of passageways and ducts; much of which was probably subject to high temperatures as indicated by the presence of refractory bricks. It was concluded that the structure was either terraced or below ground at the time of its use. To the north a slightly irregular linear feature consisting of concrete fused with ceramic pipe fragments was revealed.

The remains were not related to previously known building, but by careful comparisons it has been possible to ascertain that the northern foundation represented an external wall of a substantial building possibly used for zinc smelting (Fig 6, Building L)

The eastern wall also appears to have been in part revealed with a possible doorway of about 1m width. The southern wall of this building lies approximately 20m south of the northern external wall. This would mean that the two other walls mentioned above are likely to contain a free-standing building. The existence of a duct and the localised

metallurgical waste indicates that this may have been a furnace. This building does not appear on the Tithe map and because of its depth may have gone out of use soon after Champion's departure.

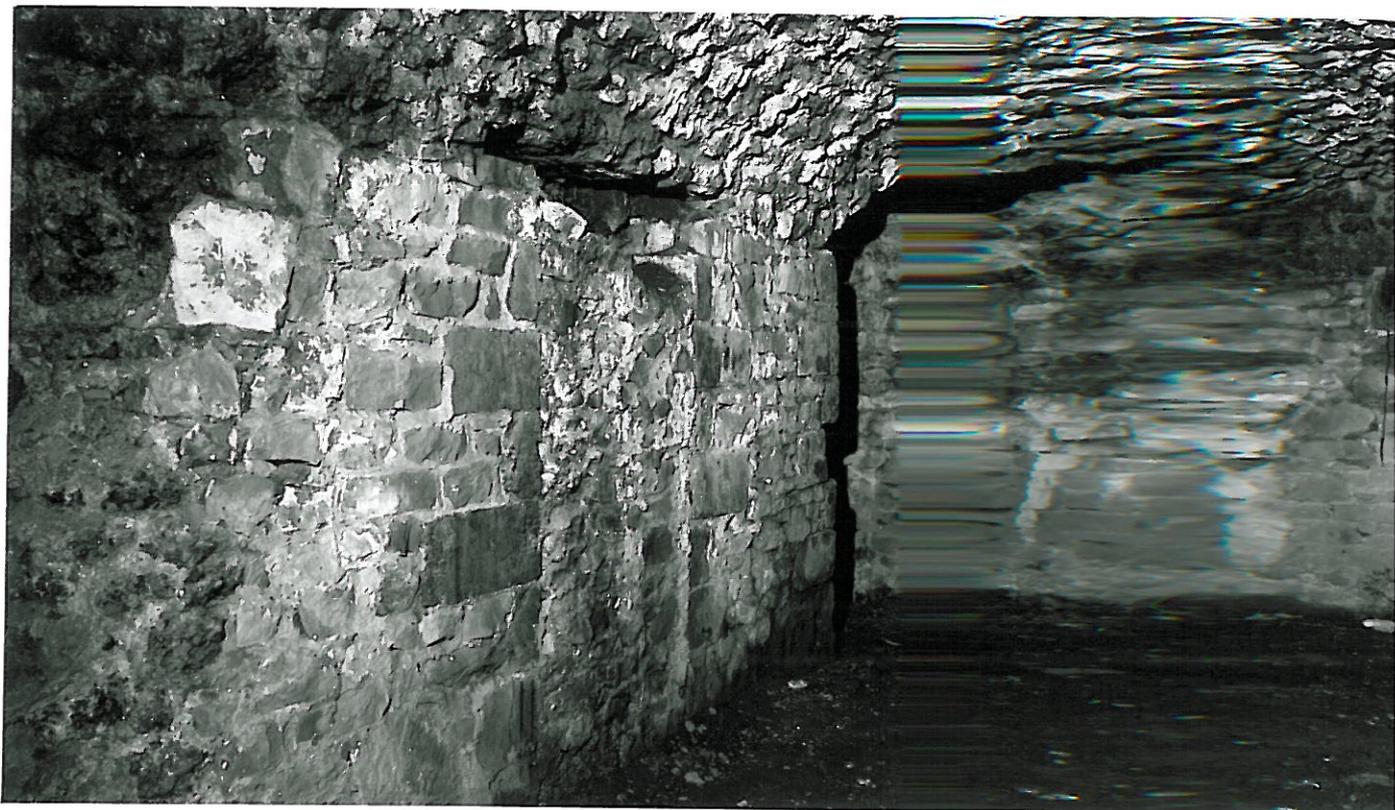
**Plate 4. The Grotto - the blocked opening in the passage**

There are some anomalies within the grotto that require further consideration. After entering the Grotto from the Laurel Walk, there is a blocked entrance in the left wall (1.25m wide) disguised by added clinker. After a further 1.45m the wall turns at right-angles to the north, and 1.7m along there is a further blocked entrance (0.85m wide) with copper-slag jambs. This section is not covered in clinker and the wooden lintel above the opening can be seen although it has almost completely rotted away (Plate 4). After a further 1.3m the passage turns at right-angles again into a passage that is blocked at its western end. At the corner there are alternate header/stretcher copper-slag quoins. The outline indicates a free-standing structure, 6.2m. wide by 3.85m. long, with two means of access, one to the south and the other to the east. This structure, which would apparently have stood outside the grotto, is now inaccessible and probably without a roof. The visible stonework, the blocked doorways and the lintel are all suggestive of a pre-grotto free-standing building rather than part of the overall design of the folly. It is possible that this was originally part of the works.

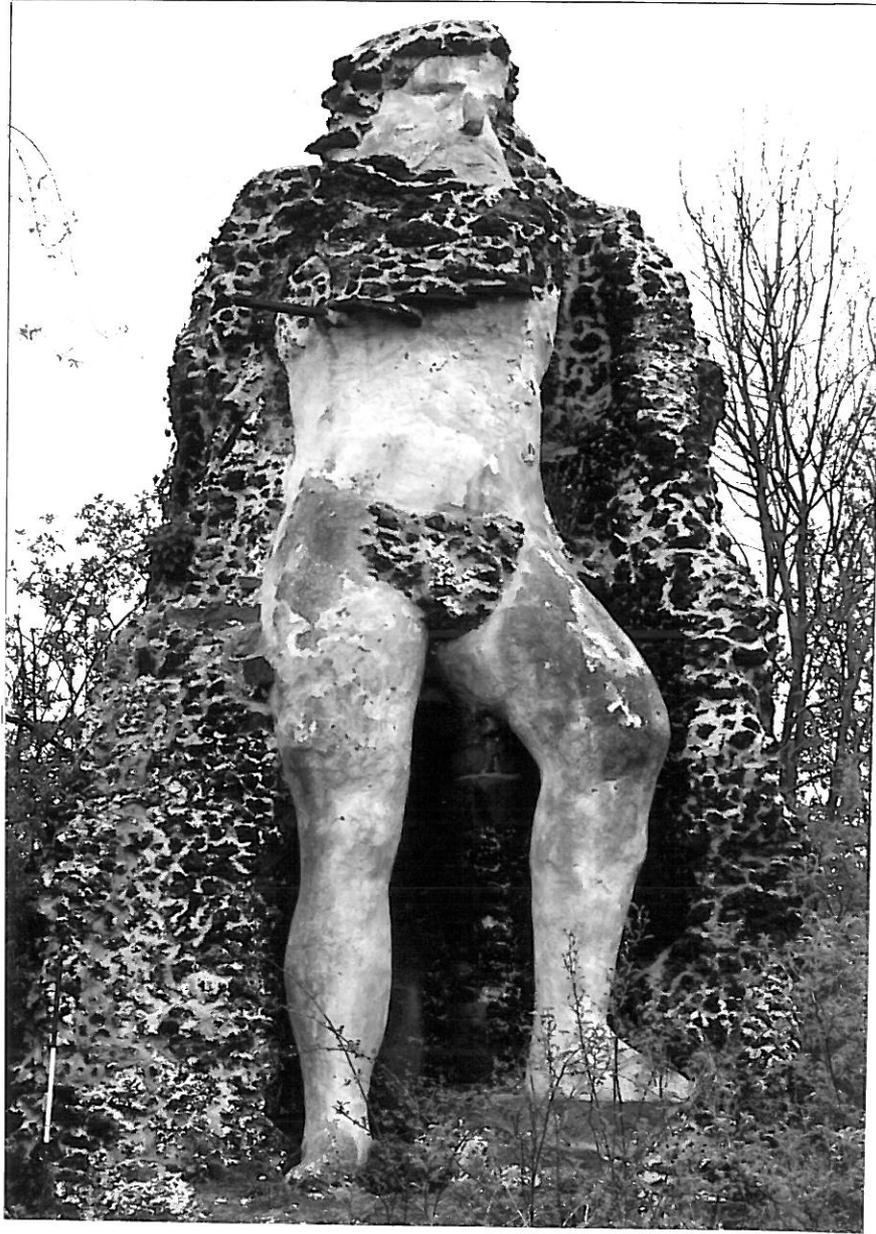
**Plate 5. The statue of Neptune**

The 8 acre dried-up lake includes the Statue of Neptune (listed, grade II) (Plate 5). The lake ran southwards from the Summer House and then turned to the east to terminate in the area of the mills. The 1841 Tithe map clearly shows the lake, but by 1881 half of it is shown as a marsh, with the Siston brook discharging into it. The southern part of the lake still appears to have contained water in 1901, and continued to be flooded from time to time until around 1970 when the Siston Brook was culverted. Much of this former lake is now given over to mobile homes (Kingsway Mobile Home Park) but the eastern arm is a car park.

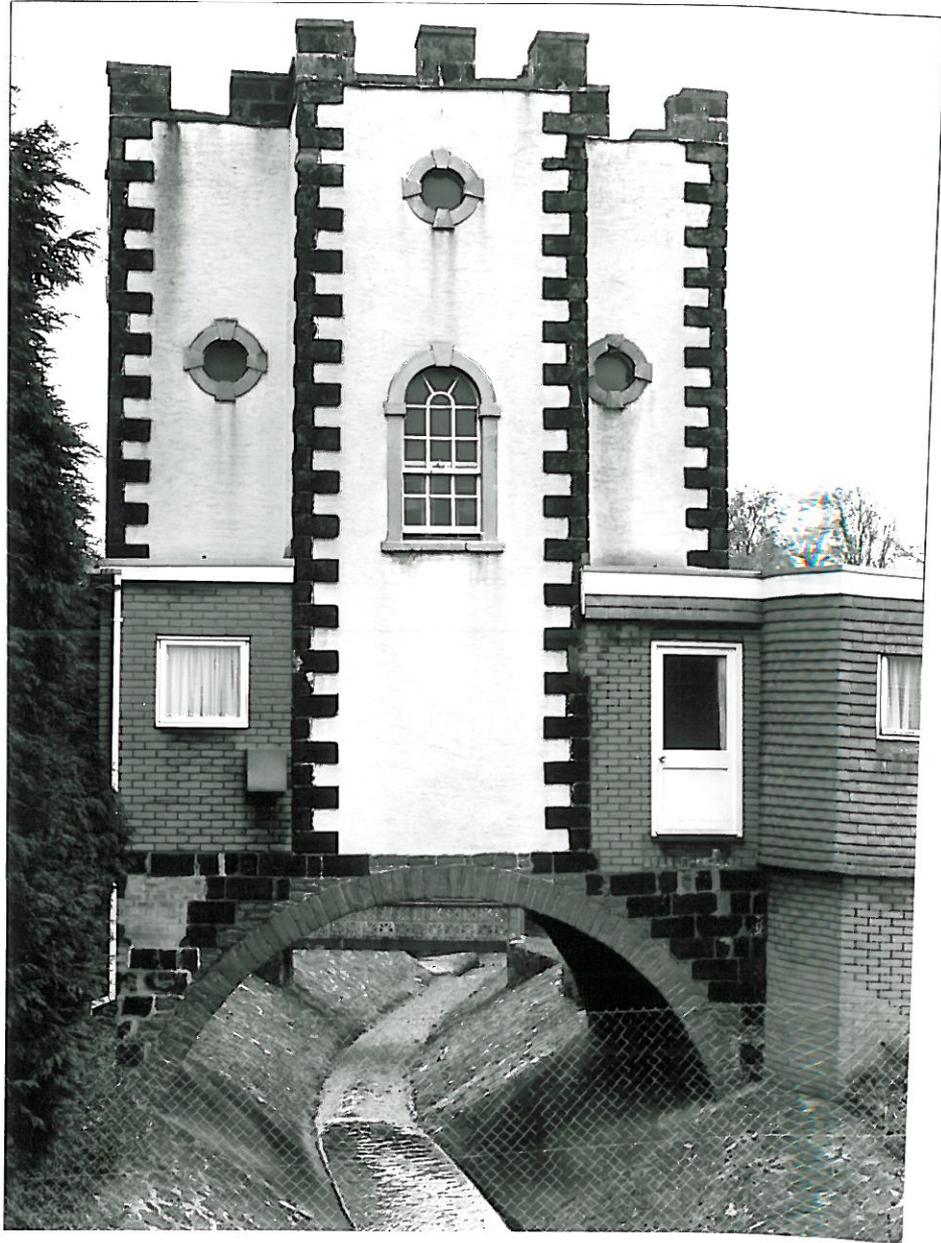
**Plate 6. The Summer House from the north**

The Summer House is built across the main flow of the Siston Brook and looks as though it should have acted as a feeder control to the lake. However, it is obvious that the main brook ran directly into the lake without any control whatsoever. The 1841 Tithe map shows the Summer House astride the entrance to the lake, with an eastern tributary running into the leat that supplied Echo Pond. An overflow from this tributary joined the main stream north of the Summer House. Presumably this tributary included a dam to divert the water into the leat. The tributary is now culverted underneath the lawn of the Summer House which is at the northern end of what had been the lake.

The House stands astride a stone arch and is rectangular, apart from a projection in the middle of the north elevation. The south elevation is of slag blocks with two windows on each of its two storeys. The architraves of the sash windows are of Bath stone with original fenestration. Two flat-roofed wings were added to the Summer House a few years ago. One is built on the east end extending the House to the south. The other is an extension to the west. Both are unsightly. On the east side of the Summer House there is a single sash window at the second-storey level, the first storey being obscured by the wing addition. The quoins are constructed of slag blocks. The north elevation is projected in the middle with slag quoins. A single-arched sash window with a stone architrave is central to the whole facade. The imposts are of projecting stone and there is a projecting keystone. Over the window is a circular window with keystones at each quadrant. Either side of the projection are circular windows of the same form. To the west the wall is plain. The east, north and west walls are rendered except for the quoins. The whole structure is crenellated giving a Gothick effect which also supports the rococo character of the garden.

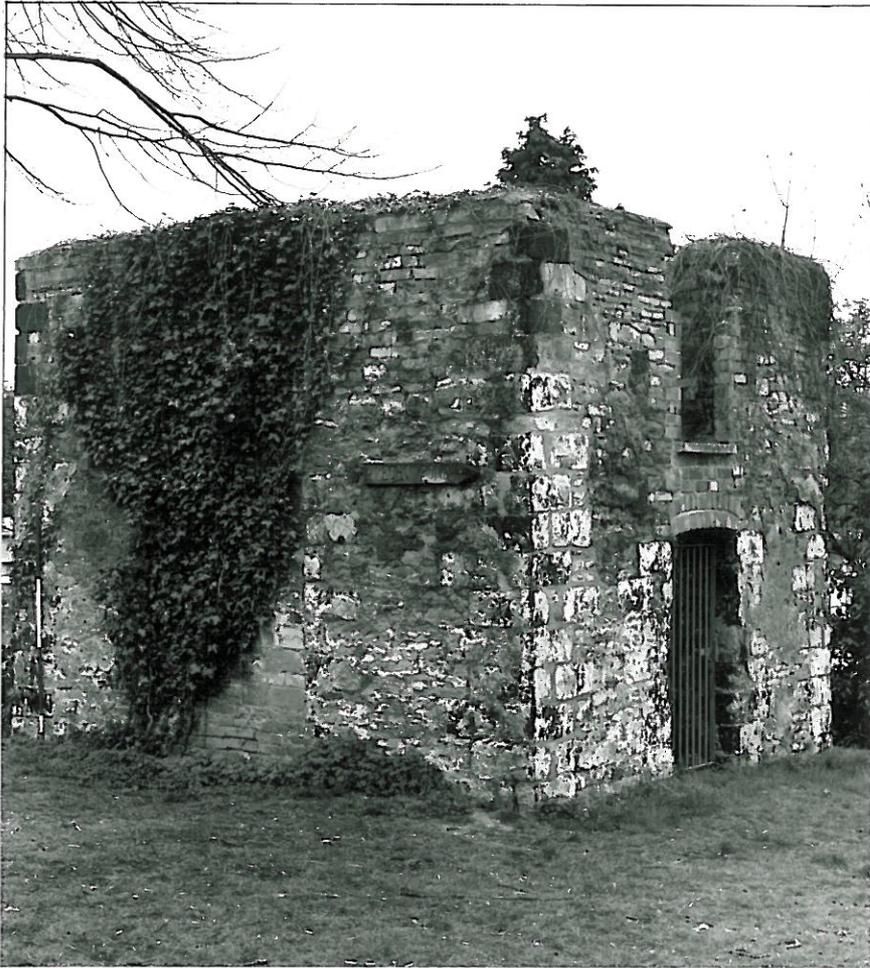
**Plate 7.**  
**The 'boat house'**  
**from the south**

The building known as the Boat House lies half within the historic garden and half in the area of the lake. It measures 4.6m. square and is approximately 4m. high on the east side. At some time, possibly at the beginning of this century, it was heightened by approximately a metre. Until 1967 it had a hipped roof, but it is now open. It is constructed of random-coursed sandstone with copper-slag quoins and the walls are 0.45m. thick on all sides. At some time it was rendered with a coal-based mortar. It is now of two storeys with a raised ground floor that was inserted in this century. In the south-west corner there is a small inserted fireplace at the second-floor level. On all sides there were arched openings 1.85m. high by 1.1m. wide. These have been partially blocked to make small windows. On the east and west sides there are secondary arches low down. The north elevation gives a clear indication of the inserted two floors; the original building being open to the roof. The second-storey window has a stone sill. The Boat House has been the subject of speculation as to its original purpose and an engine house has been suggested. Although its size and shape could well have housed a beam engine, with a bob wall supporting the beam, it does not appear ever to have been substantial enough for this purpose. Its situation half in the lake is also confusing. The later alterations must date from around 1900 when it was converted into a two-storey building to house the butterfly collection of Herbert Haskins (Howes 1993).

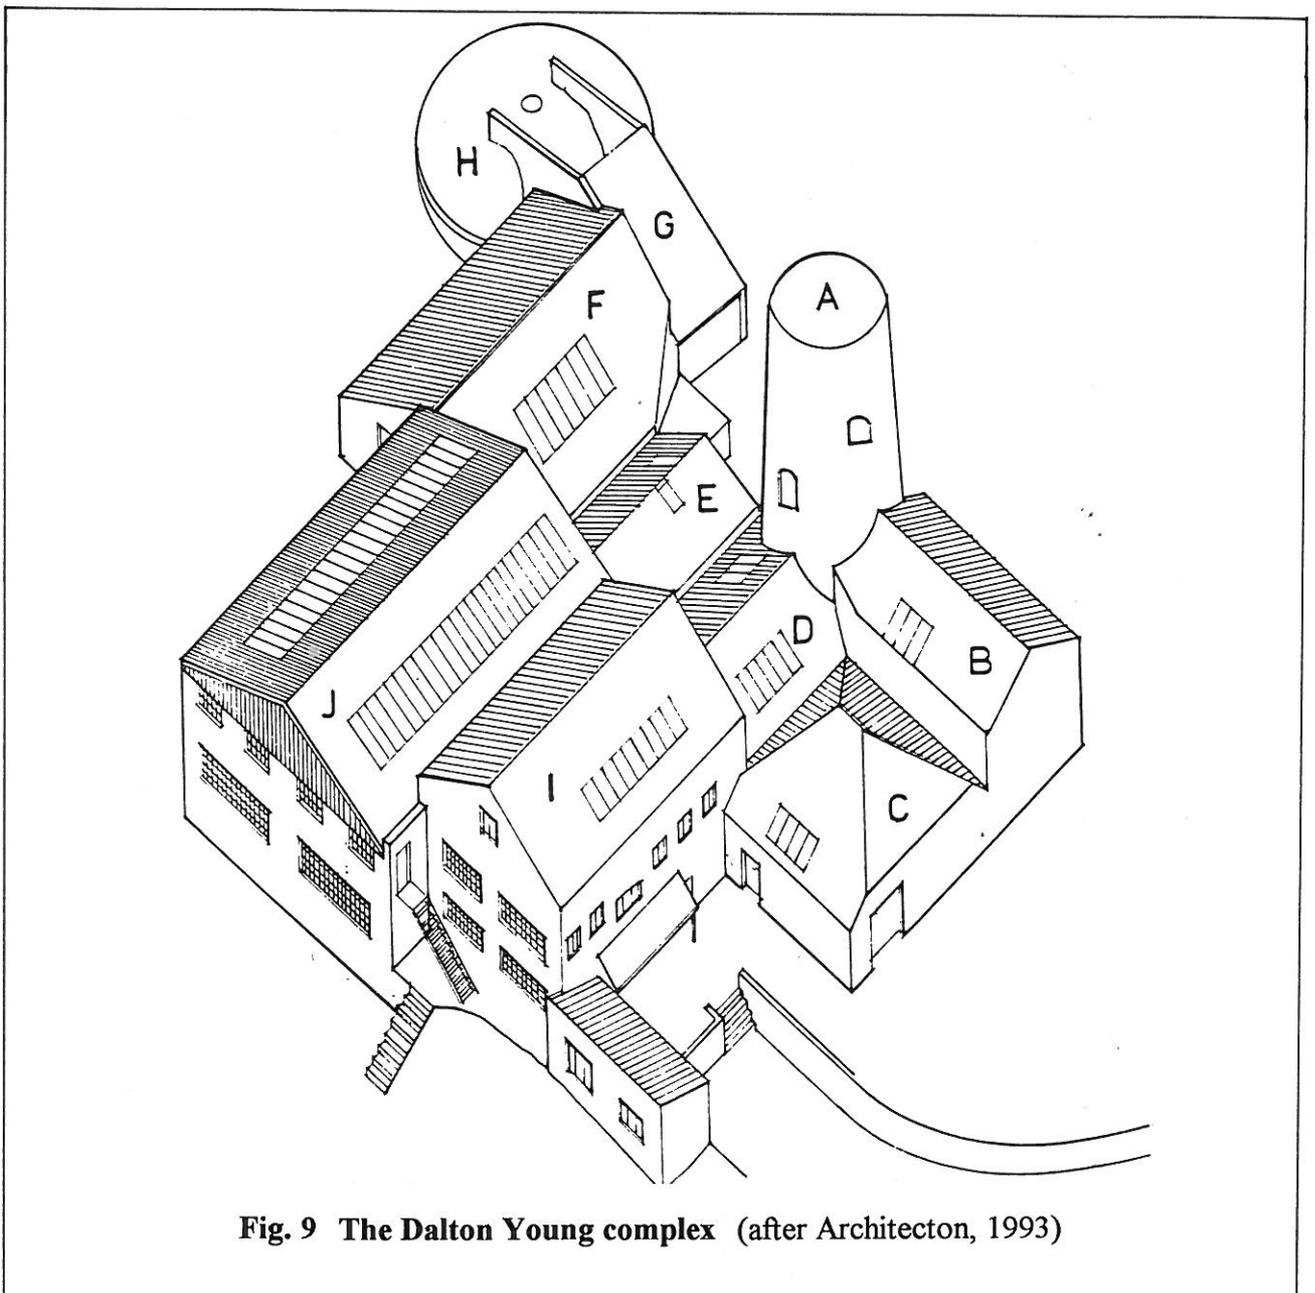
Fig. 9 The Dalton Young complex (after Architecton, 1993)

This mid 18th century range is built to the west of building B and shares a common west wall. It consists of an almost square building, approximately 8m. by 9m. internally. It is of one storey, open to the roof and is built of rubble. The roof has a tall hip with a short ridge and is orientated north-south. Internally the truss has been radically altered and the king-post has been removed. The upper sections of the truss have been replaced, perhaps at the time when the pantiles were removed. In parts of the building there are positions for bearings and shafting. Before the present concrete floor was laid there was some evidence to indicate that the building had been used for a horse-engine (pers. comm. Joan Day). Cartographic evidence of 1841 shows that there was an addition to this building to the south-east of about 12m. by 7m. The direct connection between this building and building B could mean that if stamps were there, then horse power may have been used when wind power was not available.

This single-storey range lies between D on the south, F on the north, and J on the west. Modern accretions adjoin the east gable. The two side walls (north and south) are of rubblestone. The west wall has been removed, and the east gable is of brick and later than the side walls. It all appears to be late 19th century, either an addition or replacement, and contains a central wagon opening flanked by two doorways. The roof is a plain gable structure similar to D with the openings to D from the south wall shared. In the north wall there is an inserted doorway leading to F. The Tithe map shows this building extending into J

The Dalton Young complex is, at the time of writing, being transferred to a Museum Trust. It has been found to be basically structurally sound (Architecton 1993). Although its various functions are not yet fully understood, as a largely mid-18th century industrial complex, it contains a highly significant group of buildings. It is considered that they formed the basis of Champion's ore preparation processes using horse gin and wind powered stamps. These would have localised one process in a limited area of the works saving the water-power for the battery mills. Although there is some doubt as to the dating of the north range, the whole complex, with the exception of building J, must be associated with the era of Champion's brassworks. The compactness of the complex, with its variety of building types and roof lines will, with sympathetic restoration, continue to provide an attractive landmark.

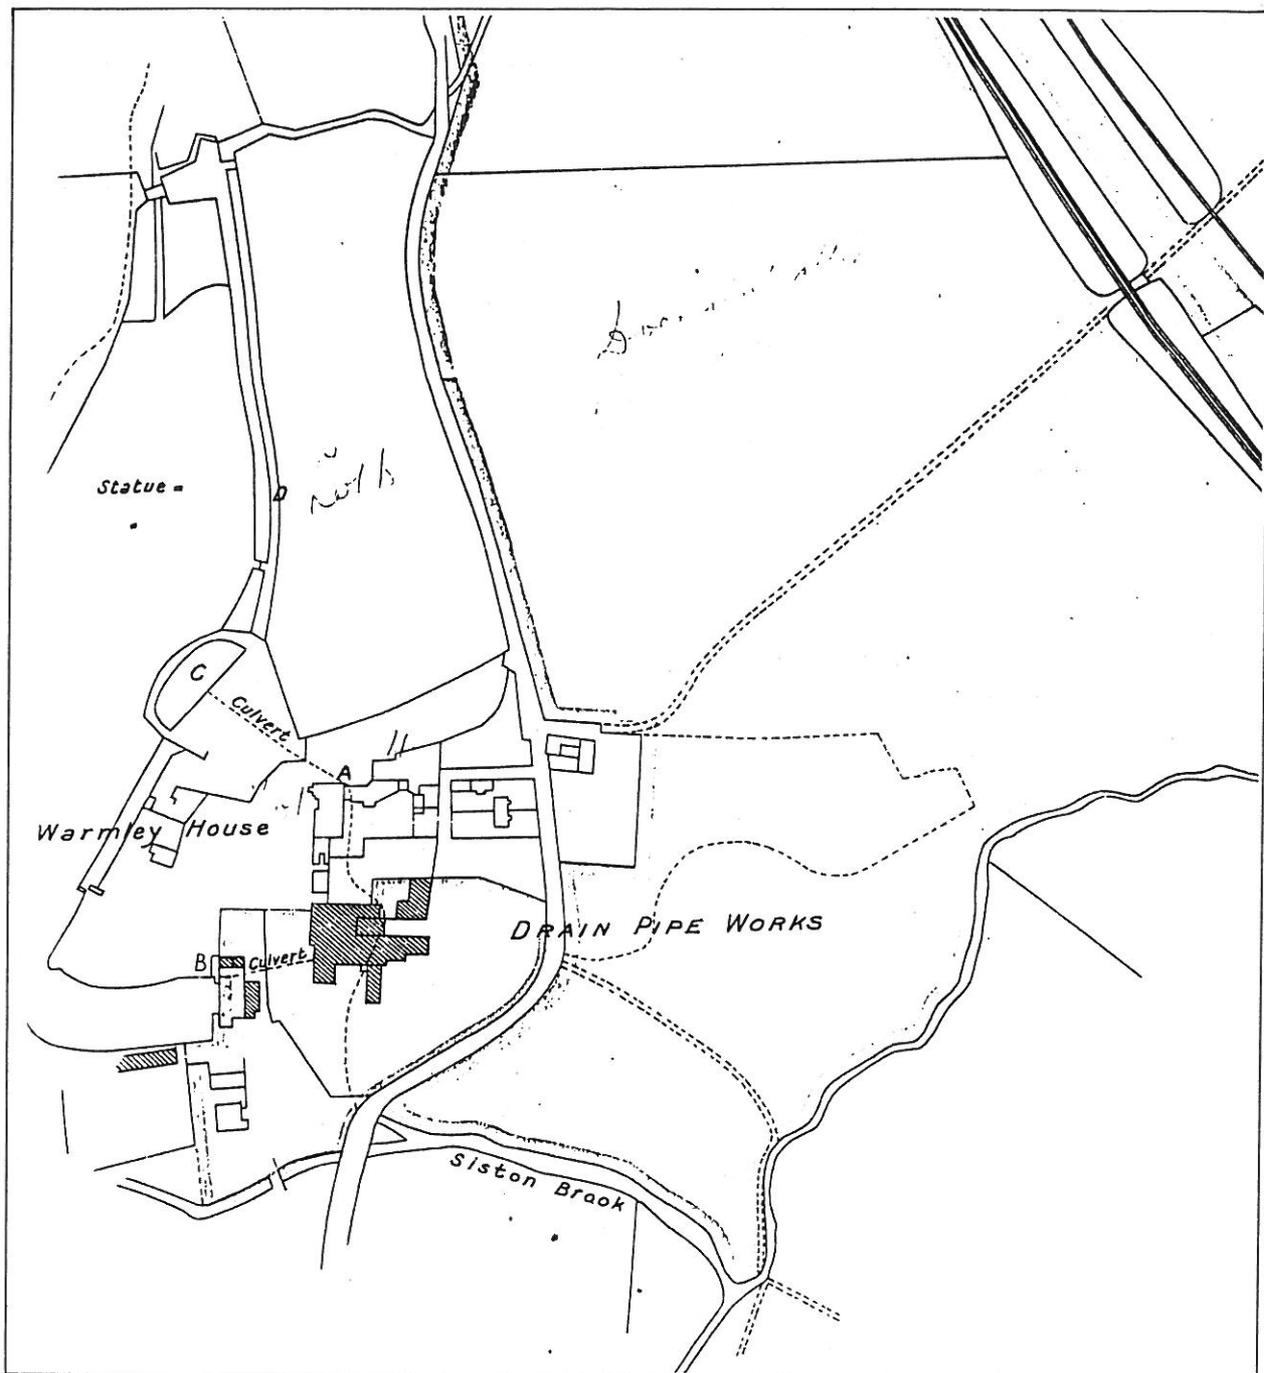
**Fig. 10** A map accompanying a title of 1889 showing culverts

Although the various underground watercourses cannot be seen they can still be considered as surviving structures. A few are known but many others doubtless remain buried. The title of 1889 shows a culvert leading from the middle of Echo Pond to the south-east corner of the lawn and on to north-east corner of Warmley House (Fig 10). From here it ran around the east of the house to terminate in the triangular pond. The title allowed Tower Mills Wool Company 'to draw or abstract water from the small [Echo] pond by means of a culvert (but not for turbines, waterwheels or other waterpower) . . . and to discharge water from the steam engines in the said business into the large Pond of Warmley House by means of culvert B.' Culvert B ran from the triangular pond directly into the lake. Another culvert has been explored from Echo Pond as far as the west lawn of the house. This has a cross-section with a pointed arch (photographs per A Bryant) and may have been for industrial purposes.

Two near-parallel culverts lead into the Grotto from the south, one at a high level to provide the cascade, and another running at a lower level. Originally, the lower one may have continued into the long bath and could have been for industrial purposes. A culvert runs from east of the greenhouse wall under the garden steps. It then turns at right-angles to emerge between the granite blocks in the chamber north of the *impluvium* of the Grotto. It does not appear to have had any other purpose apart from that associated with the Grotto. Another culvert runs north-south at the eastern end of the long Grotto passage. It may have served the cascade.

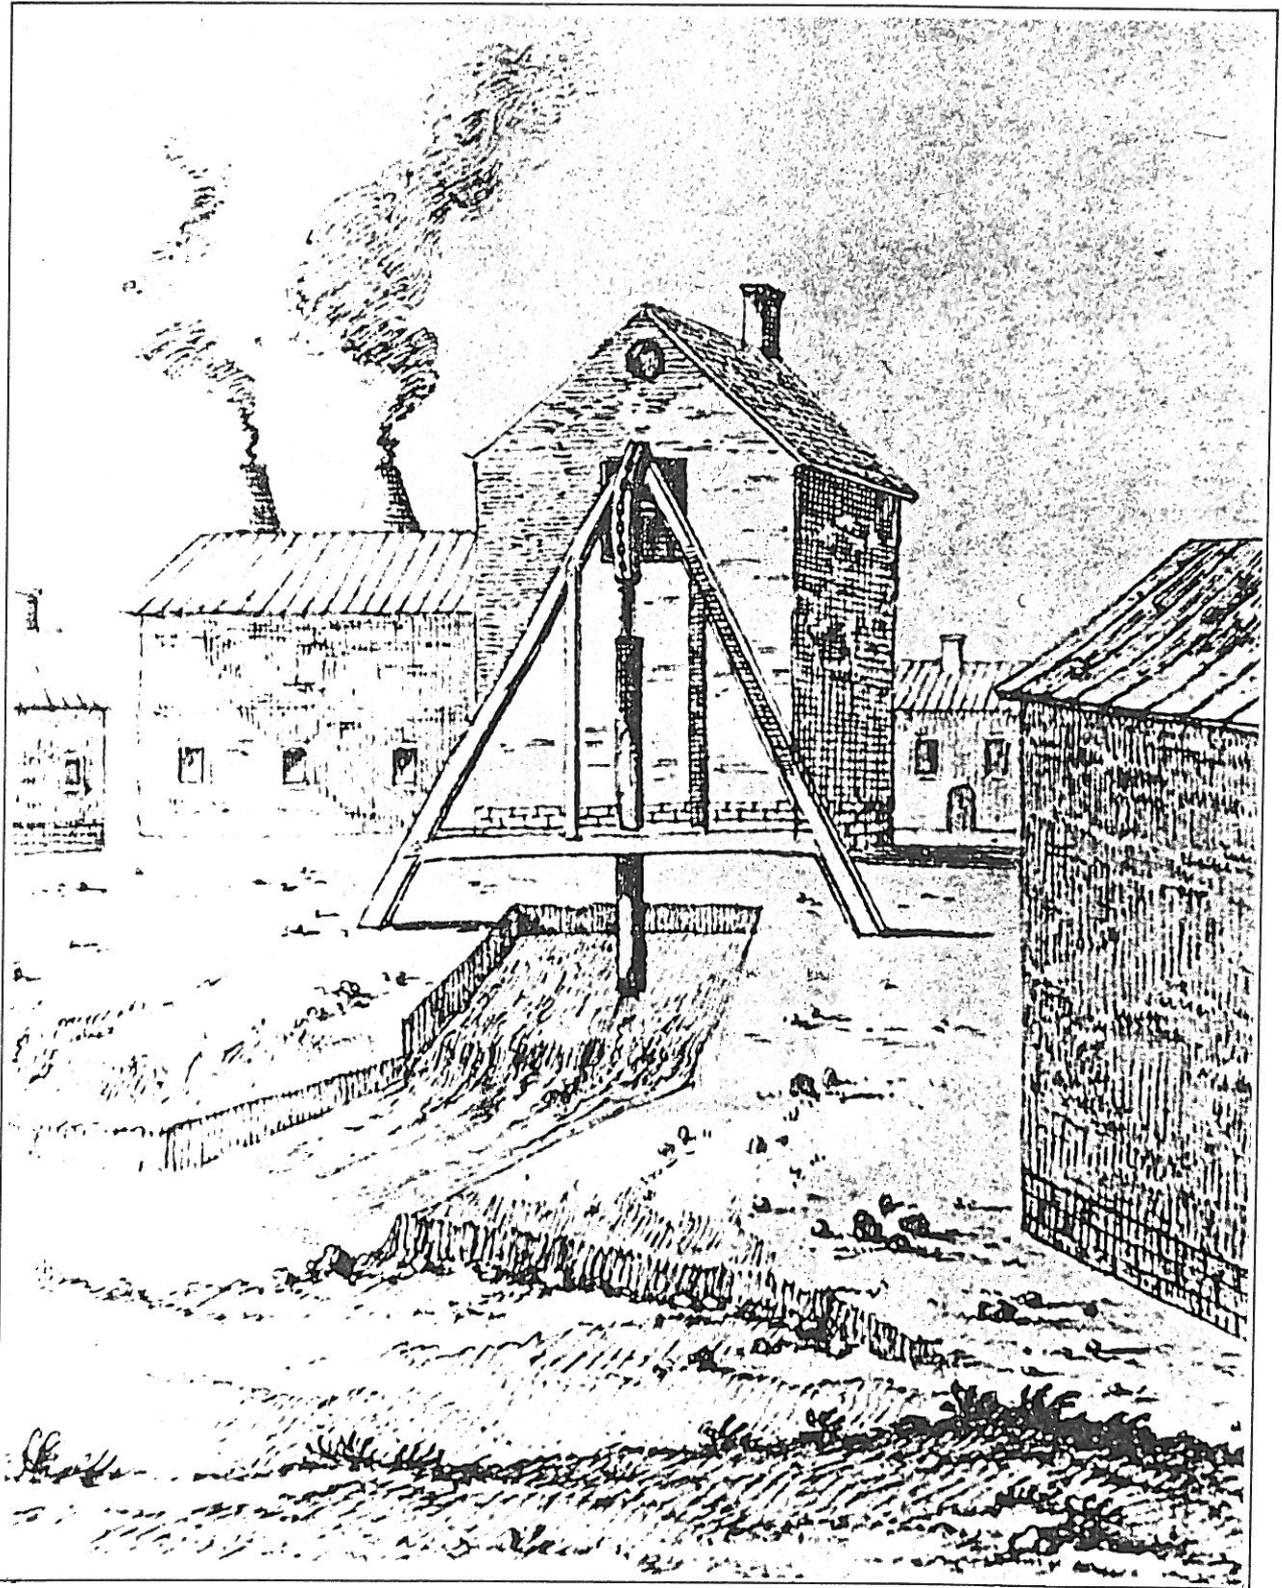
**Fig. 12** Angerstein's 1754 drawing of the Newcomen engine  
(Liverpool University)

*'What is special about this mill is that it is driven by water, which is brought up from 3 fathoms [5.5m] by a Fire Engine and then runs into a wide reservoir: from this onto the wheels and finally to the Fire Engine to be pumped up anew.'*

Angerstein's observations of a 5.5m lift are borne out by the fact that the triangular pond must have been considerably lower than the lake. The overflow from the triangular pond would have returned to the Siston brook via the remains of the leat that still survives near the roundabout. Further to this, at the date the Newcomen engine was built, its boiler would have been constructed underground including the foundations of the engine house.

The chances of remnants of this engine house, including the culverts that served it, surviving at a considerable depth, must be good.

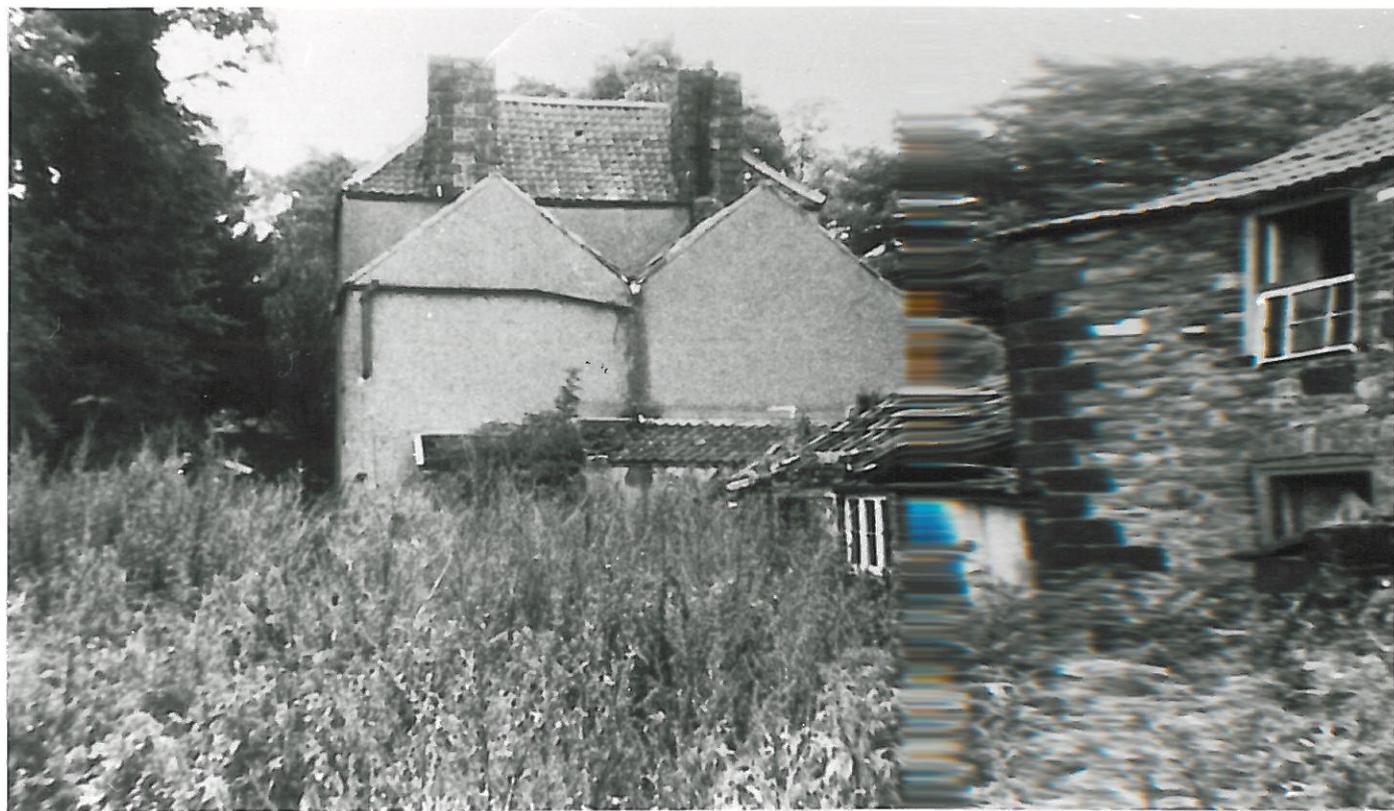
**Plate 11. The possible battery mills and slitting mills after conversion to cottages. Taken from the south in the 1960s.**

### *The battery mills* (Plate 11)

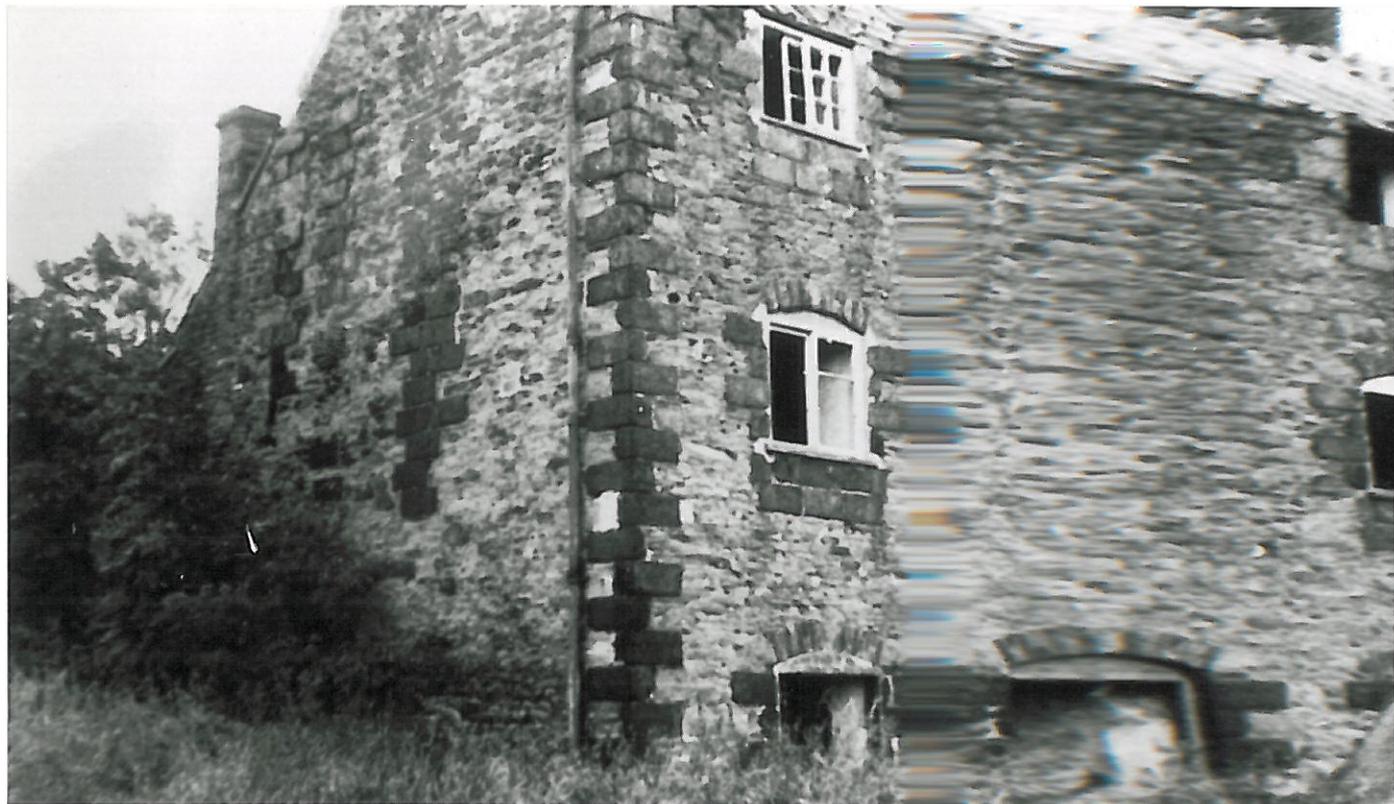
**Plate 12. Tower Rank tenements from the south-west in the 1960s.**

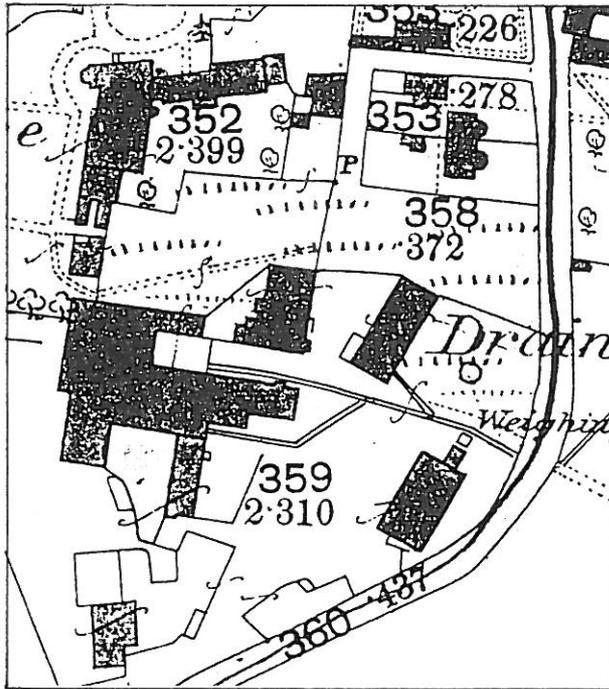
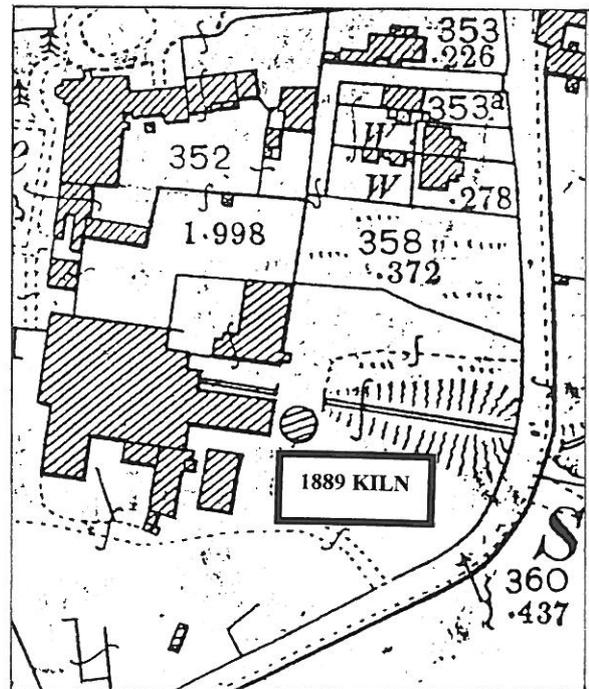
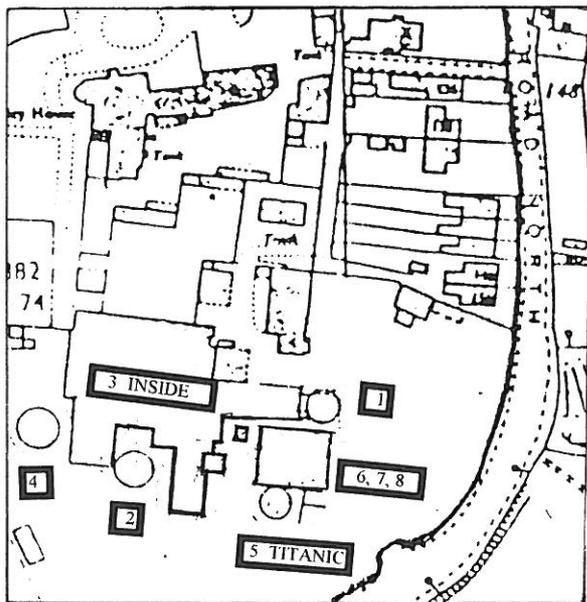
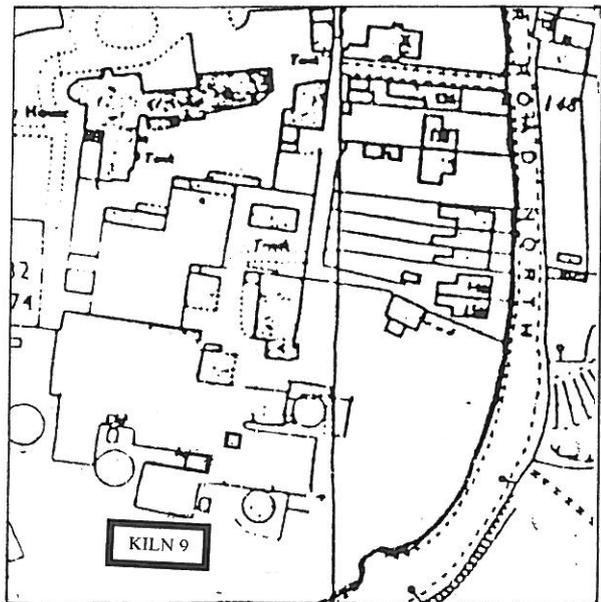
Fig. 13 The development of Haskin's Pottery works showing the kilns

By 1880, Haskins ceramic works occupied part of the area originally covered by Champion's enterprise. It appears to have utilised many of the buildings of mid-18th century character, with the addition of four beehive kilns in the open, and two rectangular buildings which also contained kilns. The two stacks completed most of Haskins undertaking.
