# WARMLEY BRASSWORKS

WARMLEY,  
AVON

A SURVEY  
FOR MANAGEMENT

June 1995

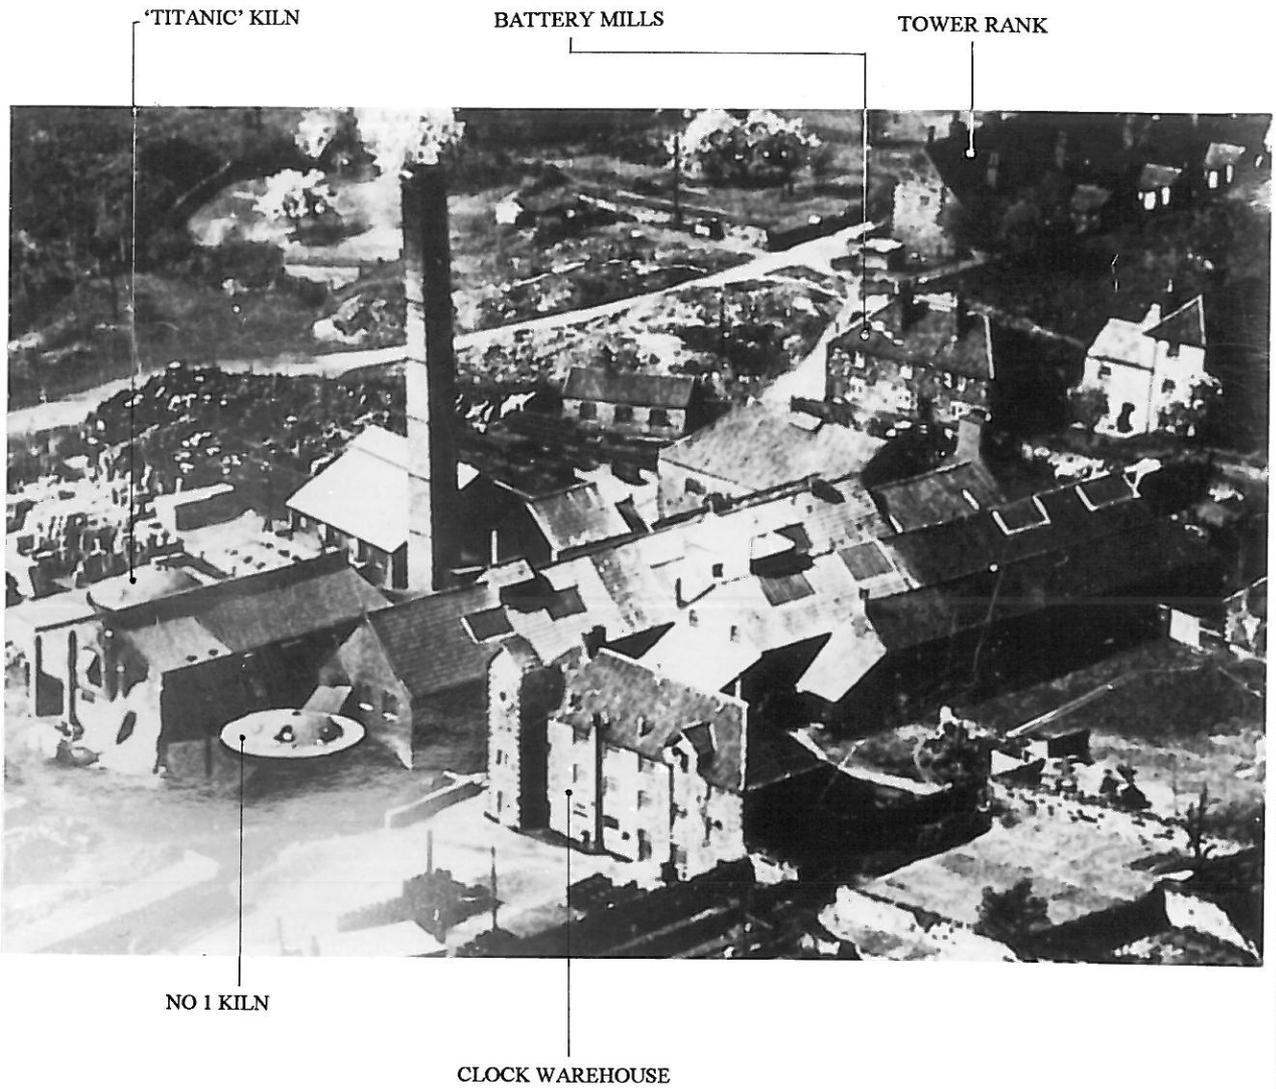
**Plate 13. Ariel view of the Haskins Pottery Works from the north-east.  
Probably taken in the late 1920s.**

An aerial view (Plate 13) was taken from the north-east well before 1957 (possibly by a Bristol firm that specialised in this type of photography in the late 1920s). Tower Lane crosses from the top right to the middle left and facing it in the top right corner is Tower Rank. The tall hip-roofed building just below is probably a domestic building noted as such in 1841, although it has some resemblance to an engine house. The two-storey

building to the left of the 'engine house' is on the suggested site of the battery mills at the end of the eastern arm of the lake. It was converted into three domestic dwellings sometime before 1841. Two of the four beehive kilns are in the left foreground, the one nearest was present by 1889. The one behind was known as 'Titanic' presumably named before the 1912 shipping catastrophe. The stack to the right was the first to be constructed, the second, further west, was not built until about 1957 (pers. comm. Jim Ashley who started work at Haskins in 1953). Built after 1902, the Hoffman kilns to the left discharged into the older stack. To the right is a tall gable-ended building that could have been an engine house close to the triangular pond. If this building is an engine house, then it is in a favourable position to lift the water into the eastern arm of the lake. The two long buildings to the north of the stack are shown on the Tithe map but the hipped building to the east of the battery mills is not although it has all the characteristics of an 18th century building. The building in the centre foreground is the Clock Warehouse.

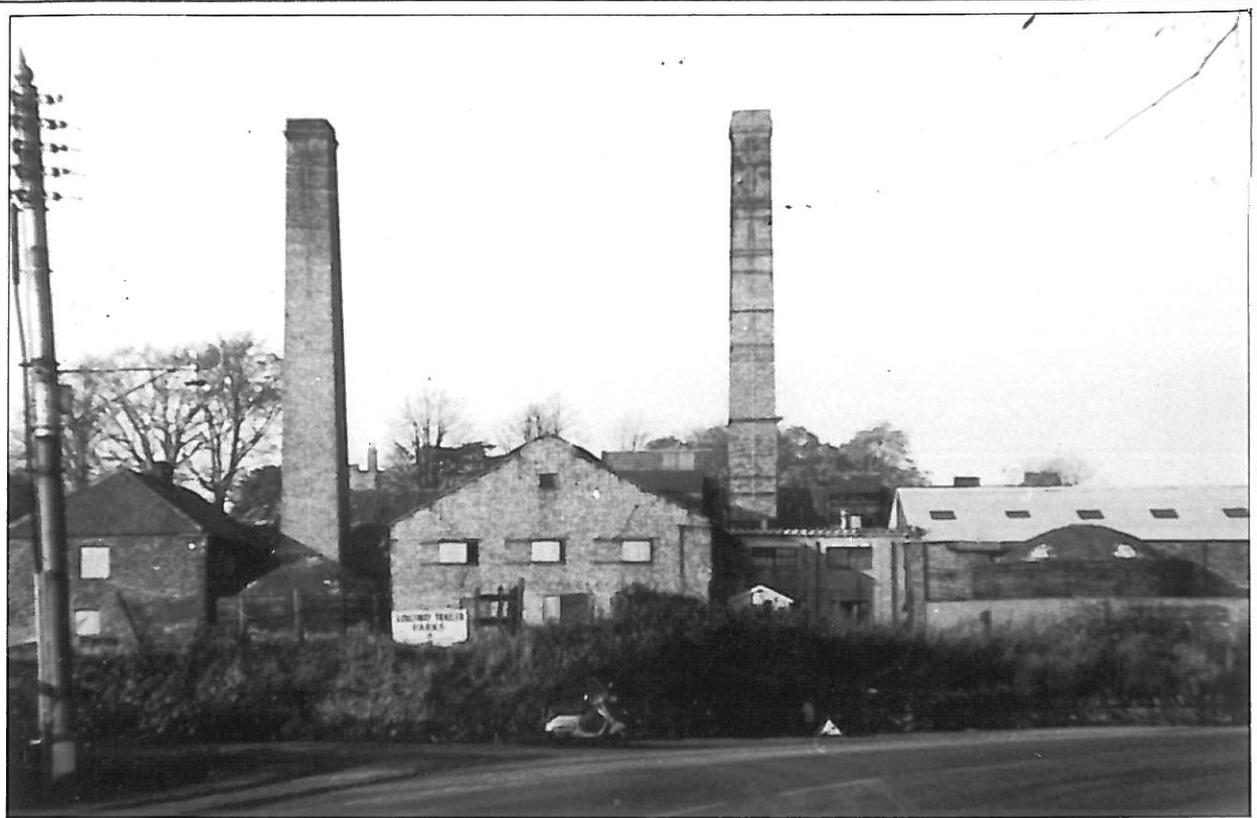
**Plate 14. The Pottery Works from the bridge on Tower Road North looking north in the 1960s. The later stack is to the west.**

The extent of damage to the archaeological levels associated with the southern part of Champion's works can be assessed when it is appreciated that, originally, the whole area would have sloped gently down southwards to the Siston Brook. Indeed, it appears from a 1960s photograph that this was still the case until the area was cleared of buildings.

A close examination of relevant photographs indicates that Champion, in order to make best use of his sloping site, levelled small areas each time he needed a new building. Thus, from an archaeological point of view, the site would have consisted of a series of small platforms, each containing a building or process. This method of construction continued throughout the 19th and early 20th centuries with further small areas being levelled as required.

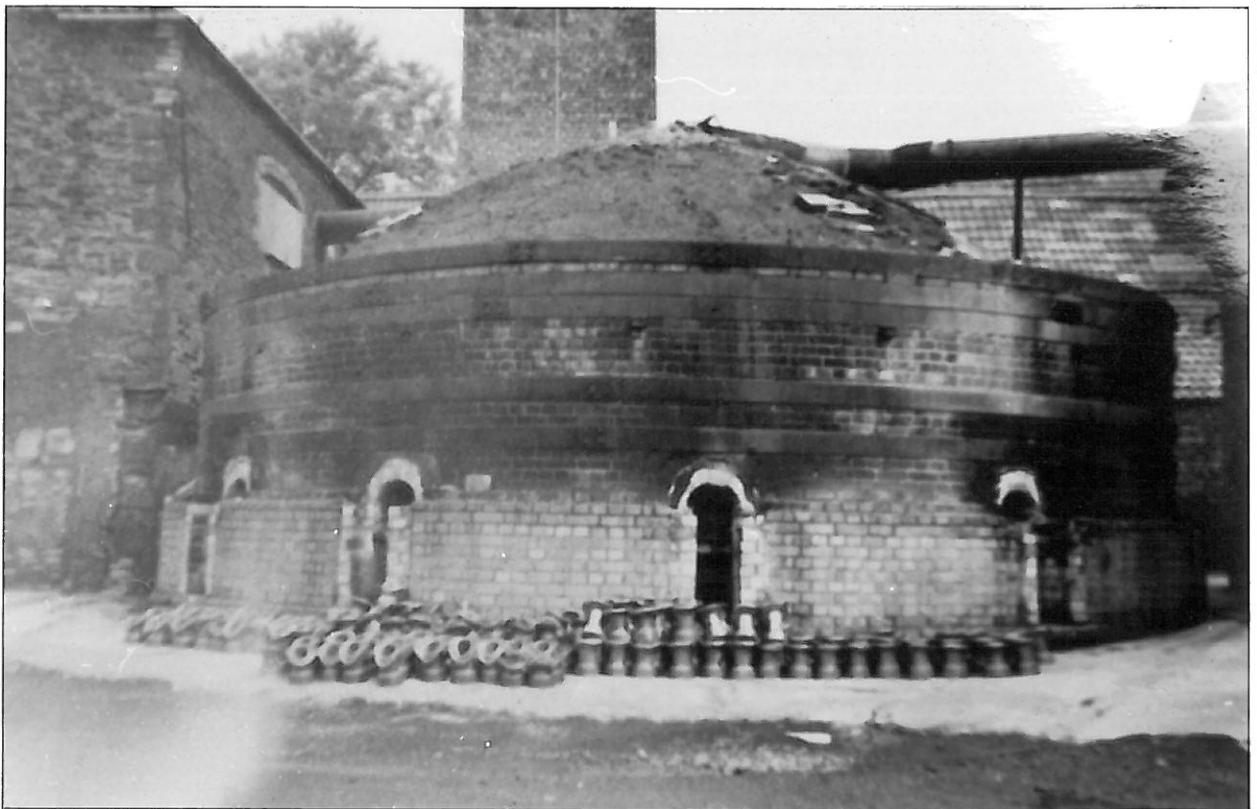
**Plate 15. No. 2 kiln and its products from the south in the 1960s.**

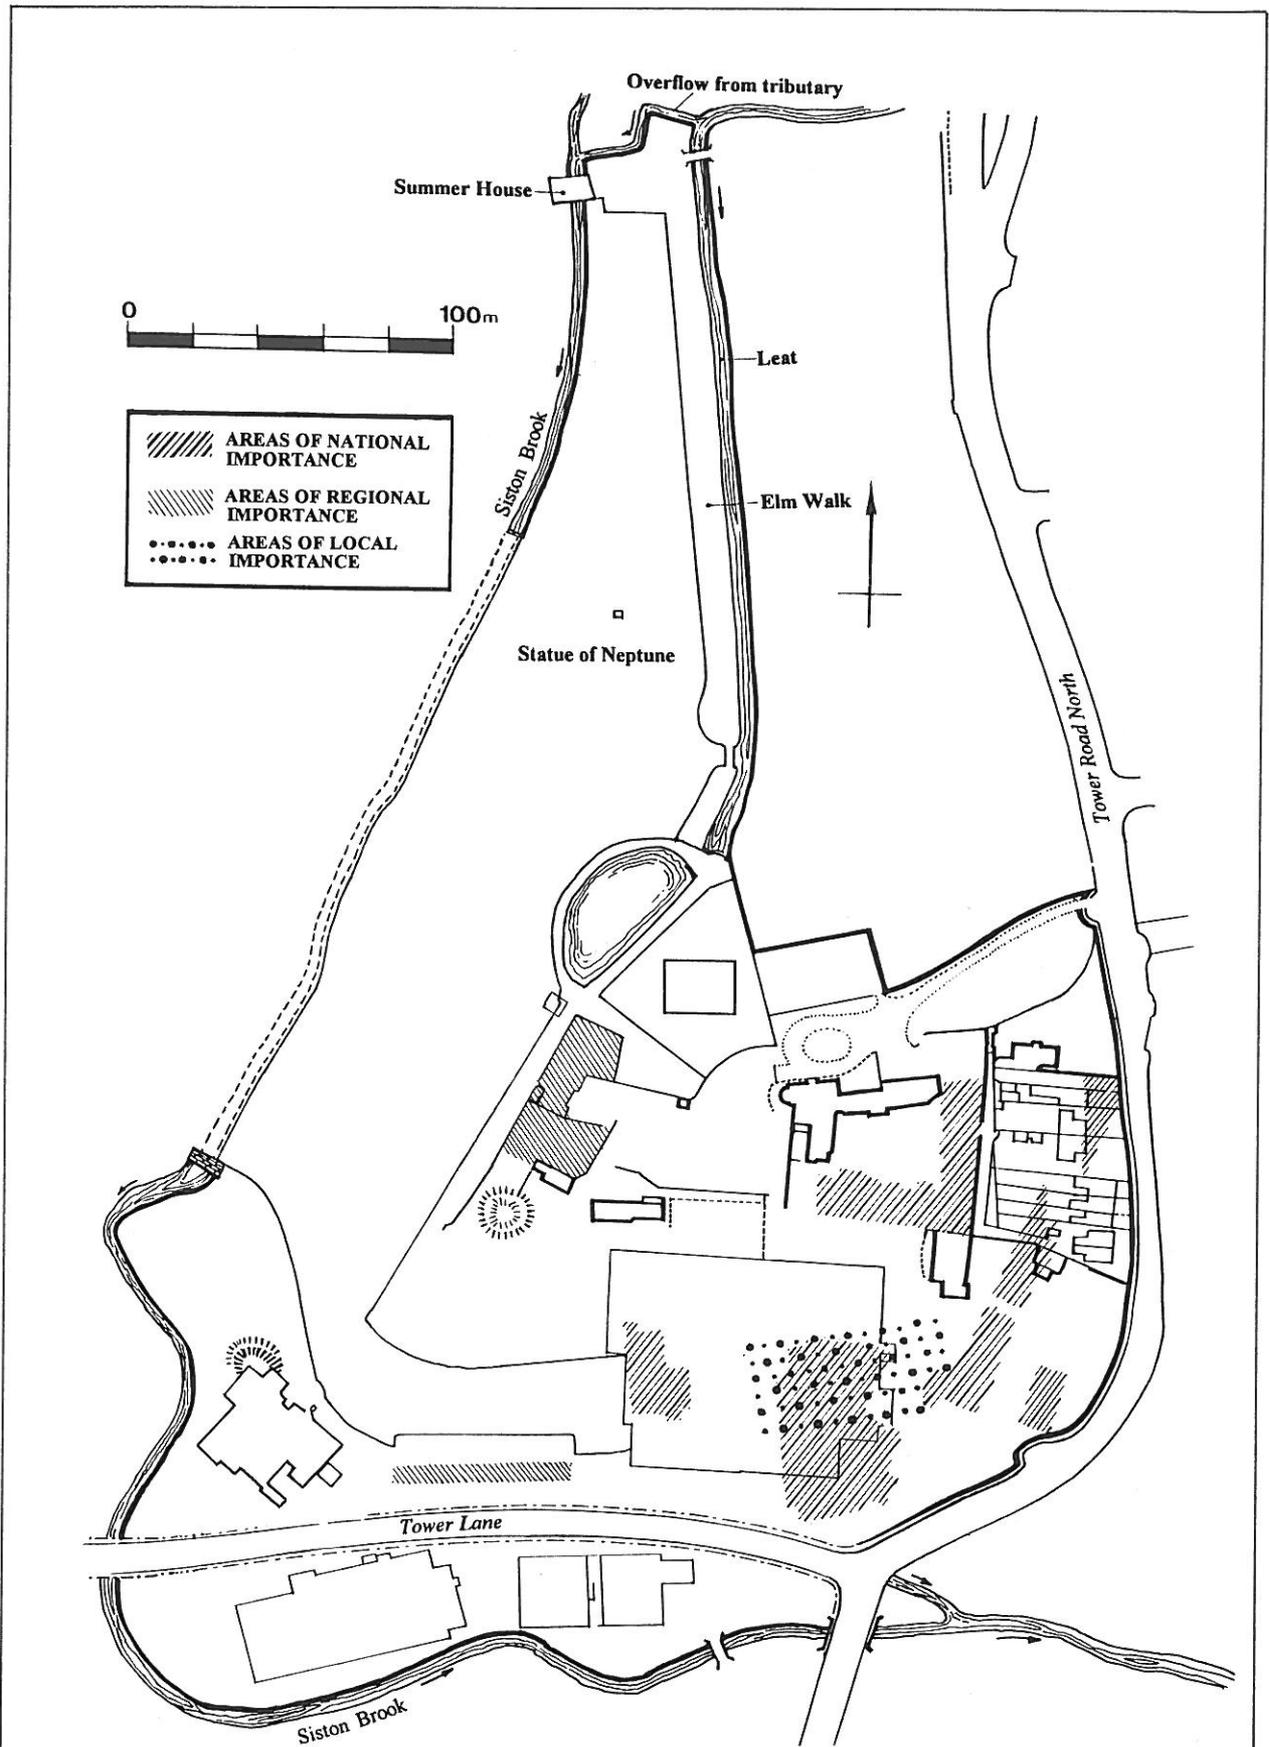
**Fig. 14** A preliminary plan to give an indication of areas where archaeological remains can be expected.

The areas where buried remains of national importance can be anticipated are shown on fig 14. They include the suggested sites of the various processes that were in use during

the Champion period including the Nawcomen engine, the battery mills, the copper & brass furnaces, the casting areas, the zinc smelting areas and the annealing area.
