SALTFORD BRASS BATTERY MILL
SALTFORD
AVON

A CONSULTATIVE REPORT

**SALTFORD BRASS BATTERY MILL
SALTFORD
AVON
NGR: ST 687 670**

Richard K Morriss
MA MSocSc MIFA

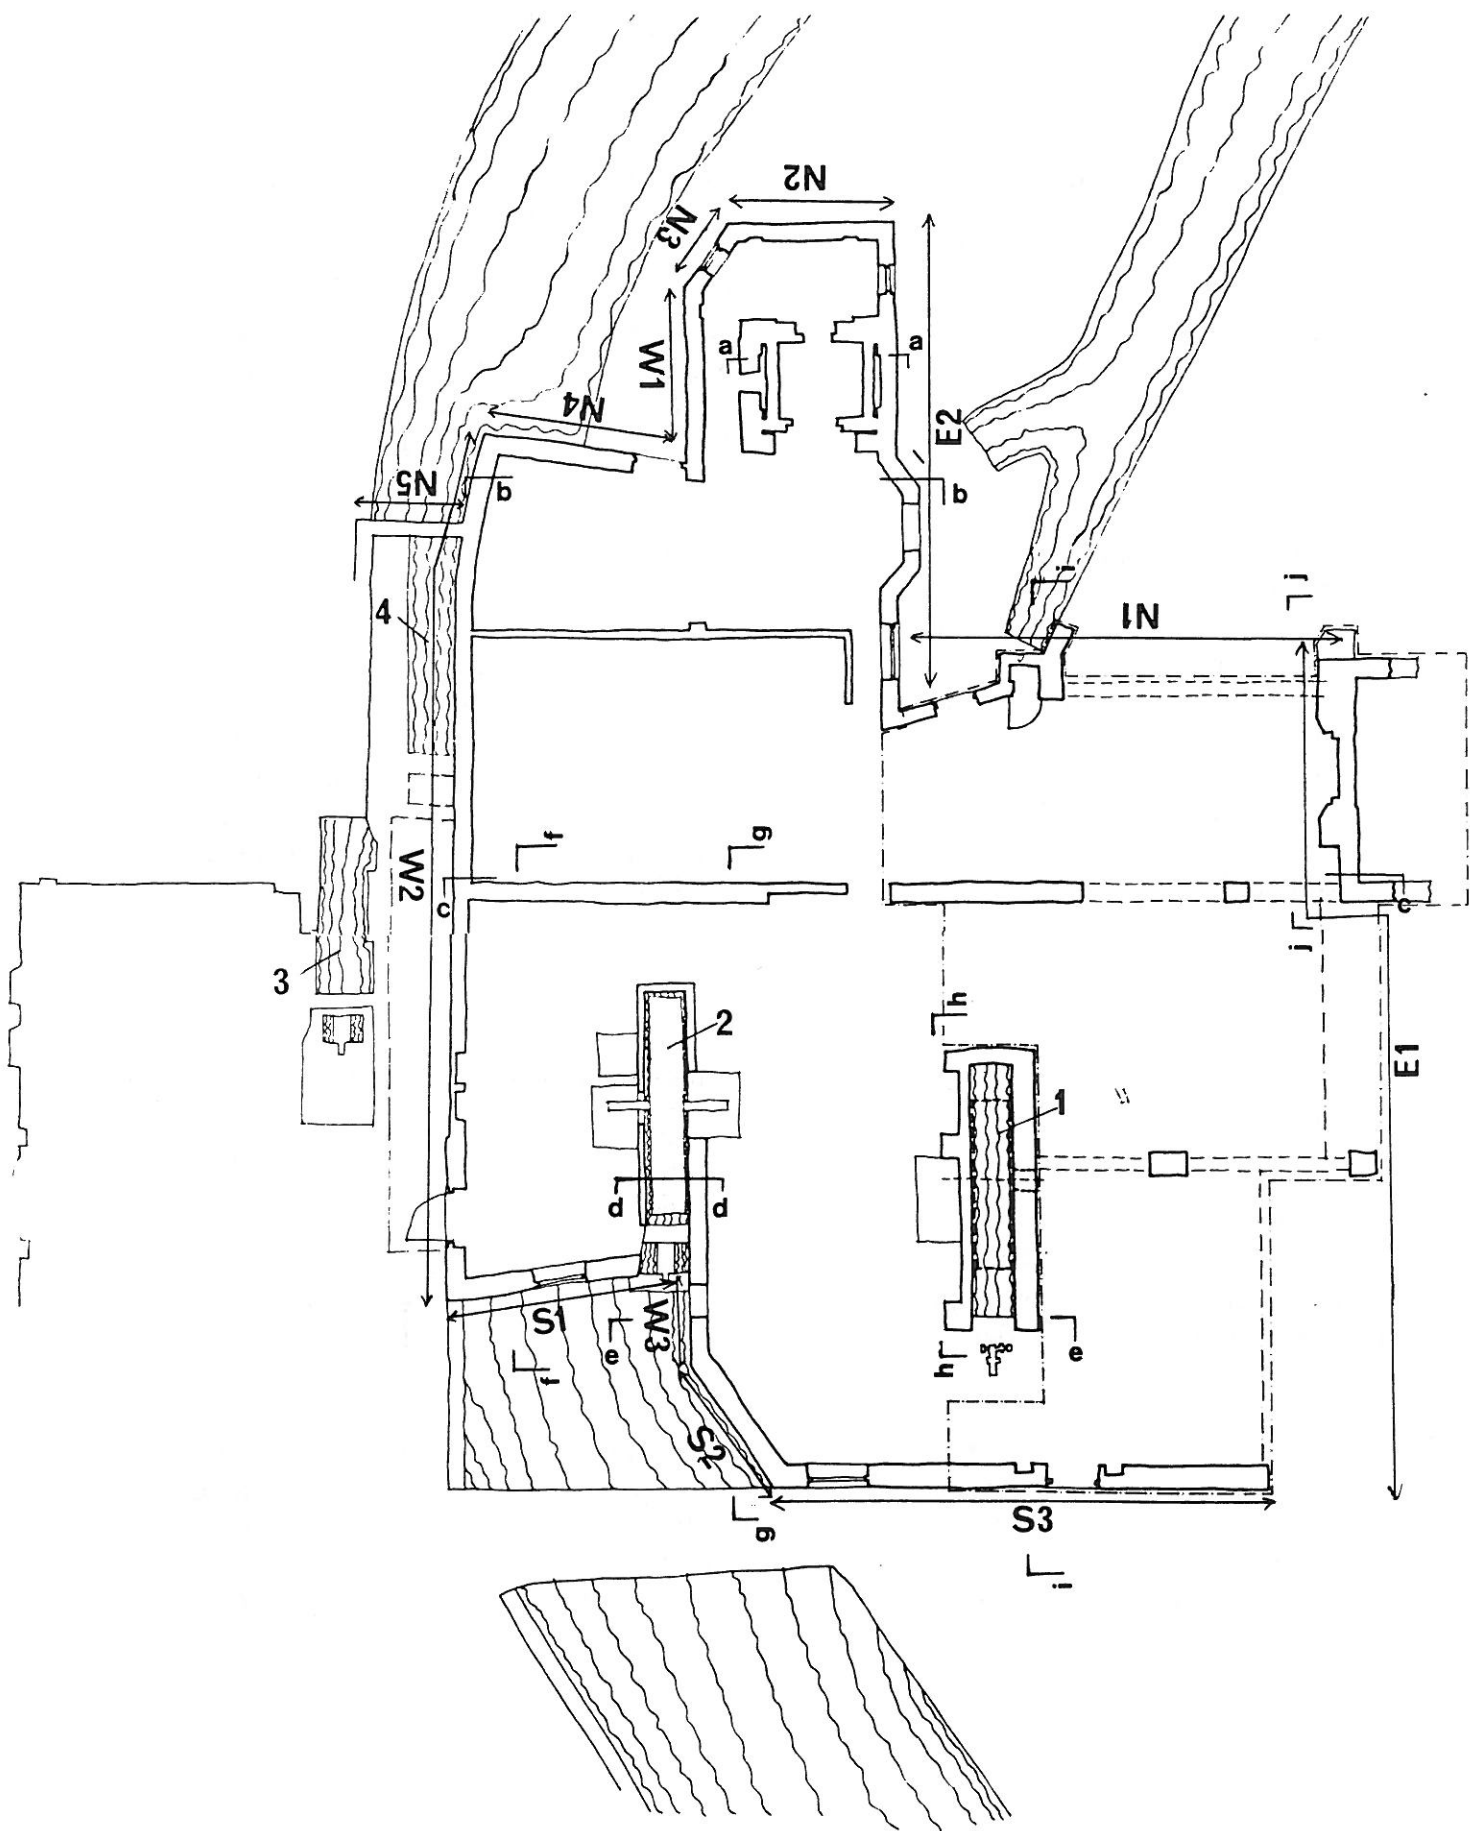
SALTFORD BRASS BATTERY: Plan of Main Complex with Identification of Elevations & Cross-Sections

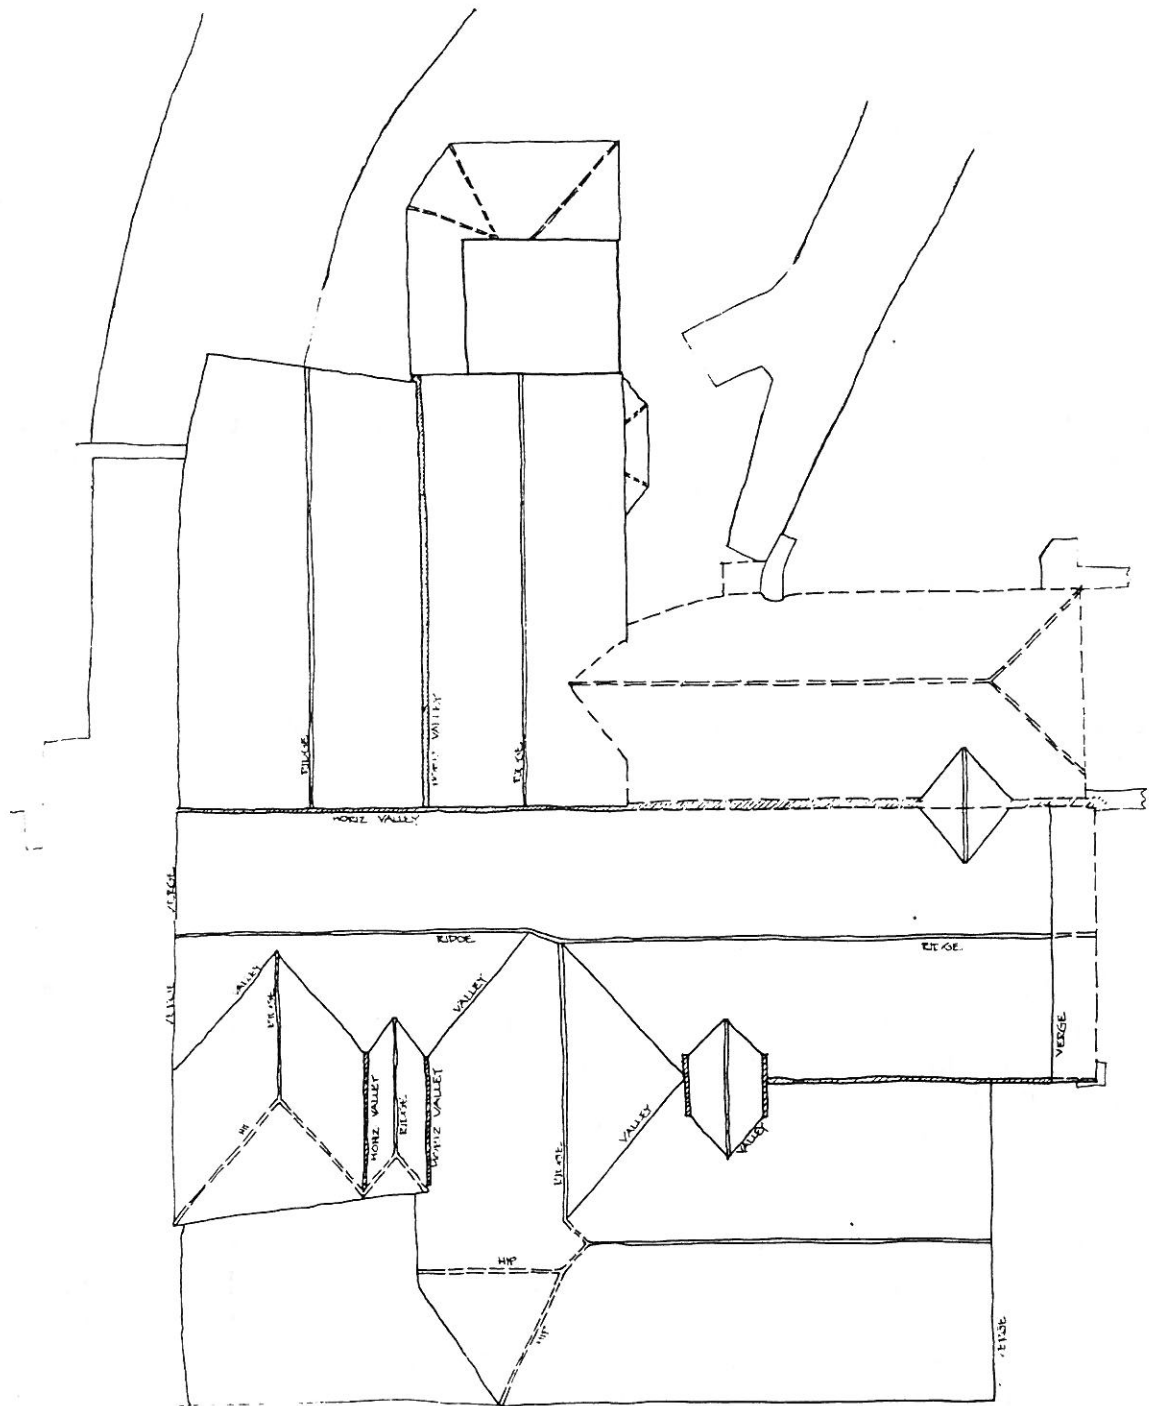
SALTFORD BRASS BATTERY: Roof Outline Plan.

The roofs are all wide and high - and secondary. The roofs in the northern portion are both 20th century in date. The double-pile over the squash court area has its shared valley supported by an RSJ; this seems to be contemporary with the insertion of the squash court itself and the roof is therefore of comparatively little importance. The roof structure associated with the restored annealing furnace was replaced recently as part of the restoration work, copying the designs of the roof that was already in place.

The roof structure has clearly been subject to considerable amounts of repair and alterations over the years. It is suggested that the king-post trusses are earlier than the 'A' frame type, and that most of the changes made to the king-posts was carried out after they were in place.
