Salford Brass Mill

Watercourse Inspection and Penstock Repair

Survey Report

January 2019

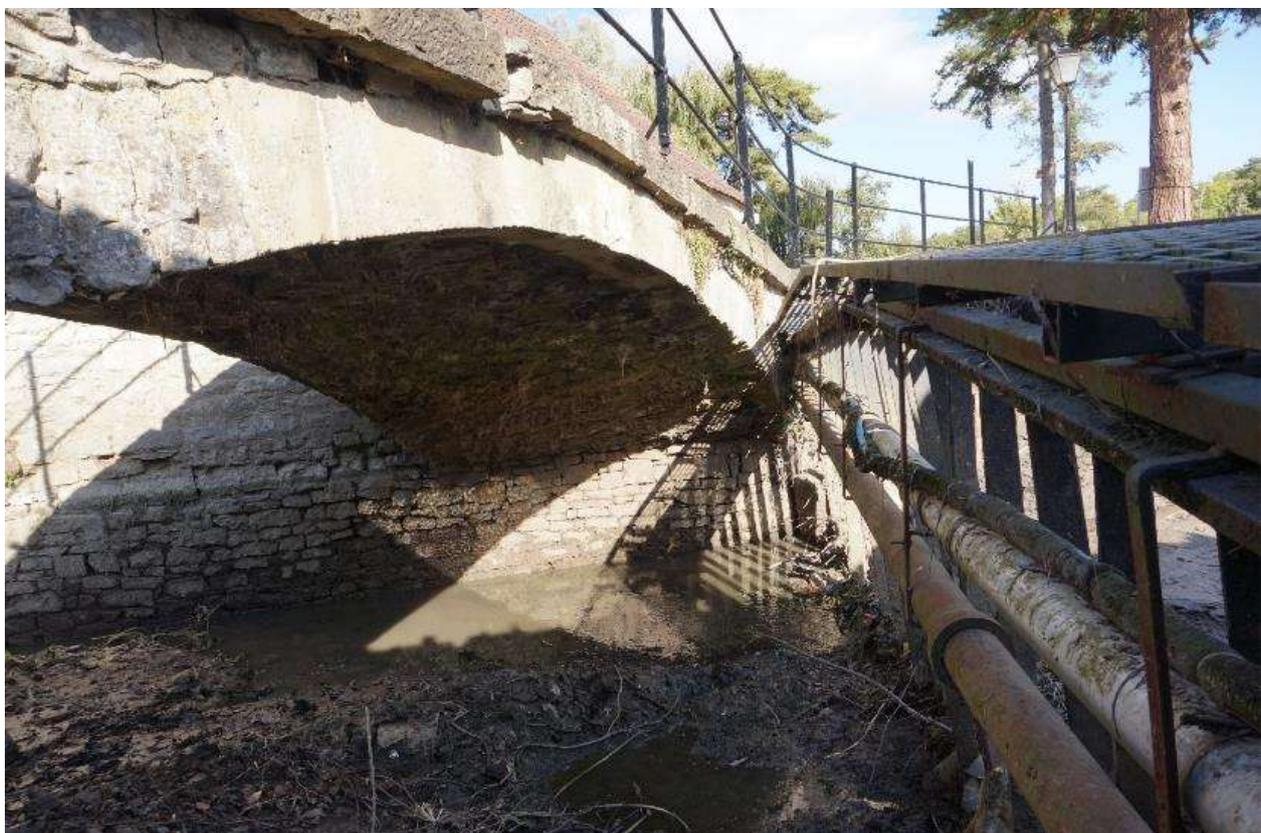
Figure 8 Southern Road Bridge - Watercourse

The bridge structure appears stable and there is no evidence of movement. Two cracks are however visible running east-west along the length of the western arch along the inside of the voussoirs [Figure 8]. The damage is more significant on the northern side of the bridge. The voussoir at the south west springing is also showing signs of freeze-thaw damage to the stone work.

Western span of the road bridge showing springing from central pier

The damage to the stonework should be monitored and a future programme of repointing developed when the watercourses are next de-watered.

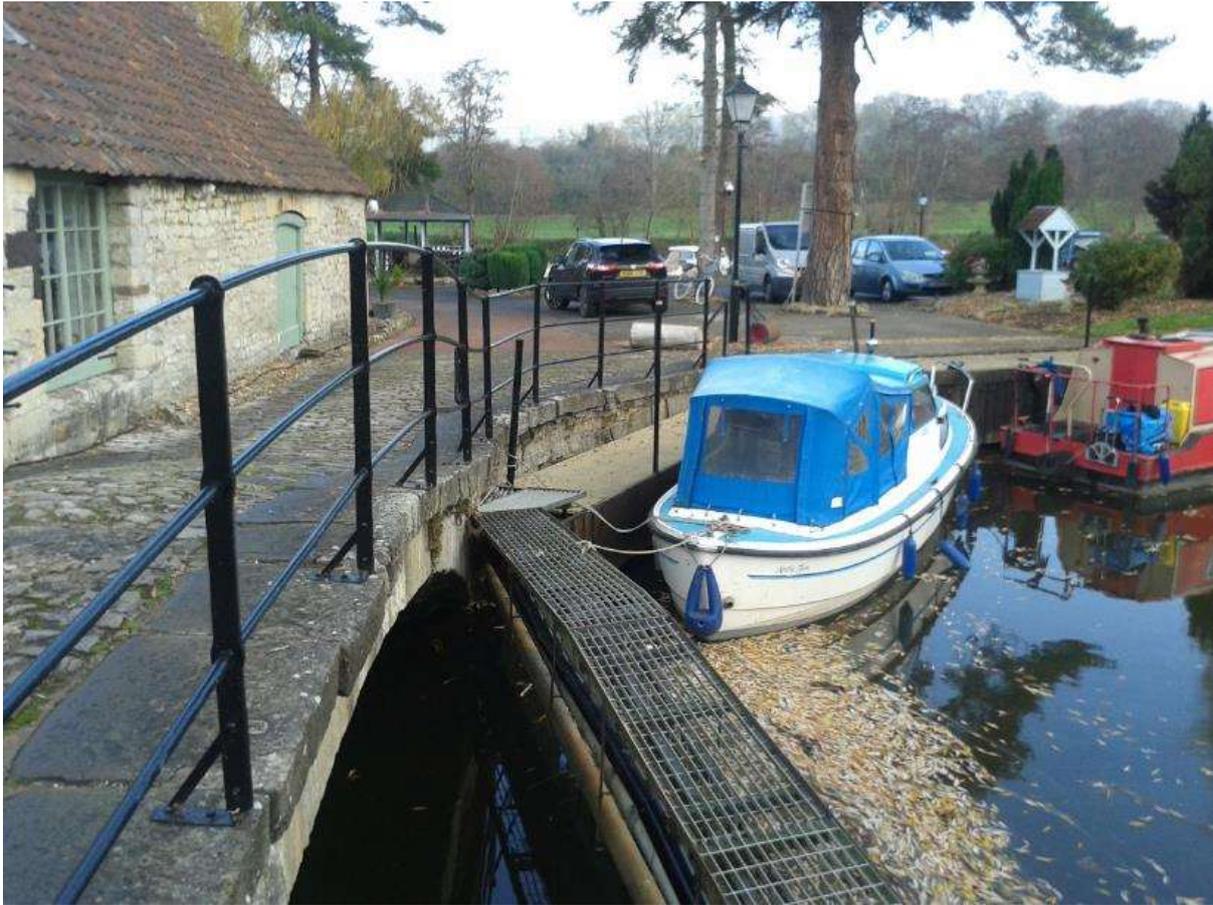
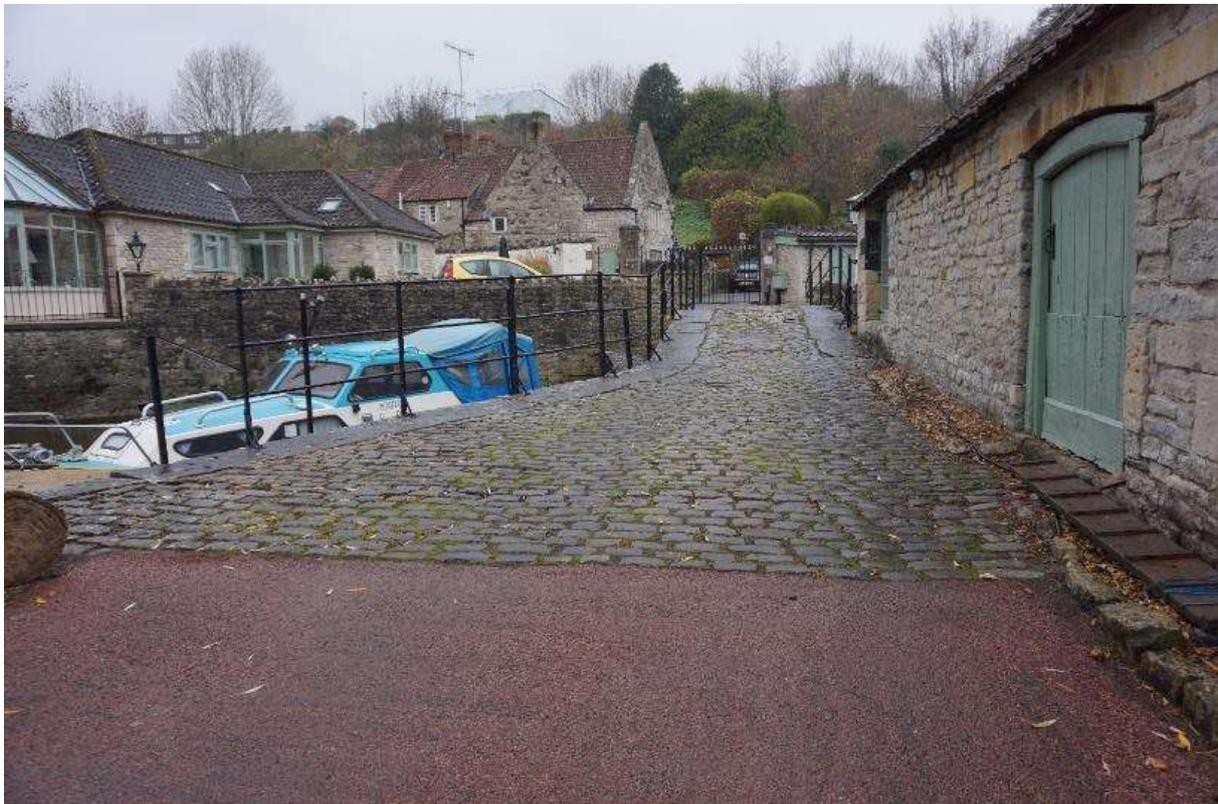
Figure 9 Southern Road Bridge – Deck

Western Span of road bridge and apron extension

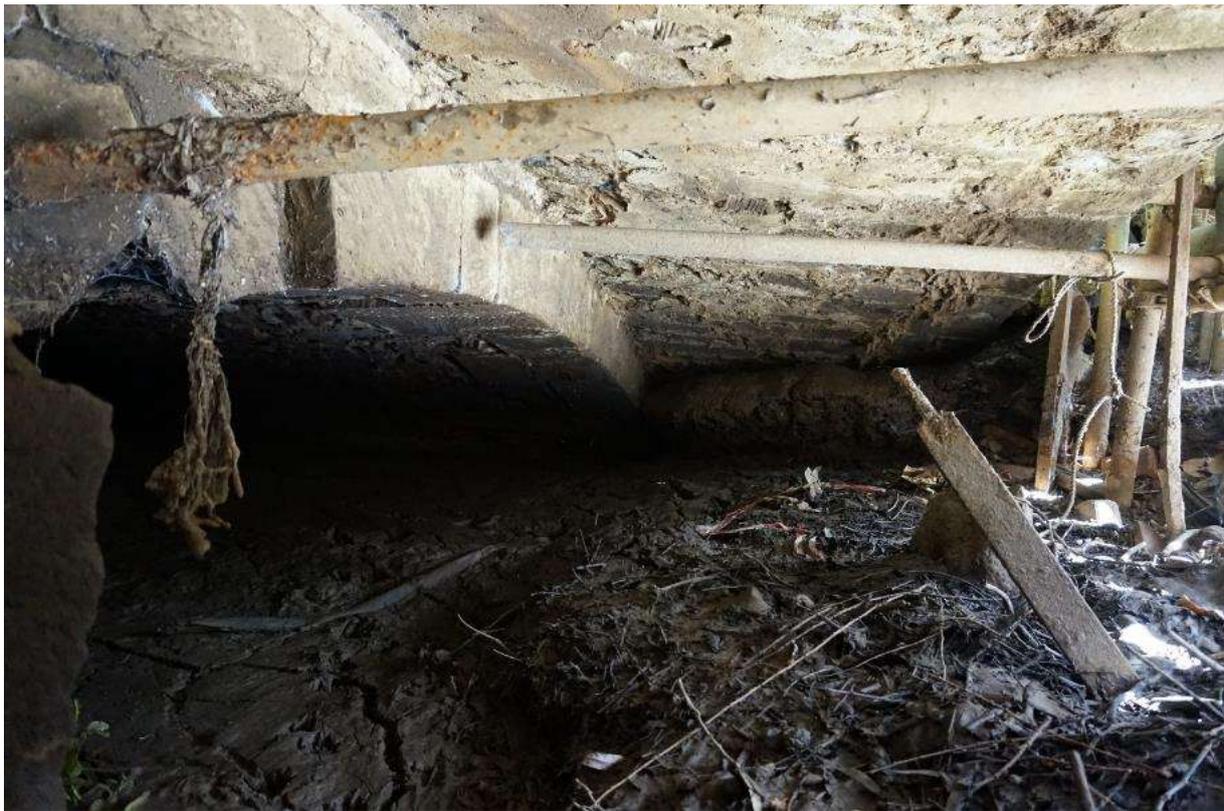
Entrance to Watercourse W0 showing southern extension to the roadway

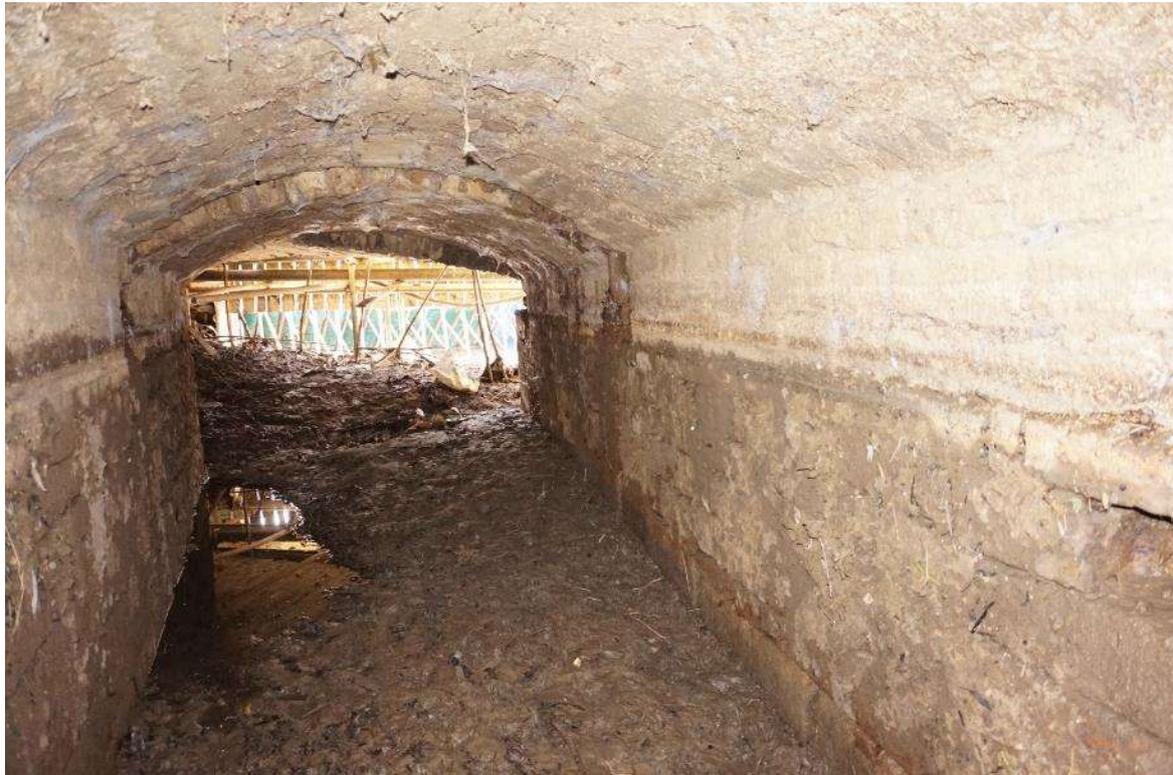
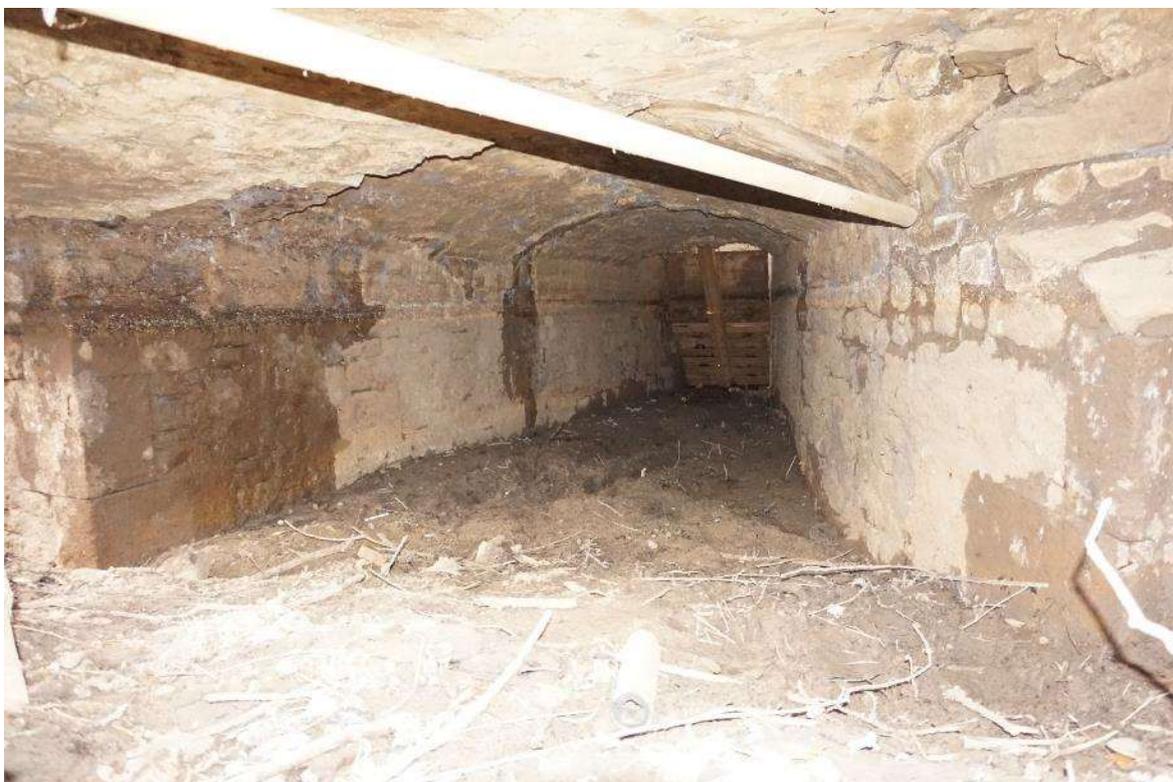
Figure 12 Upstream Watercourse W1

View from penstock-gate W1 looking upstream

View from Watercourse Entrance looking downstream – New Gate installed

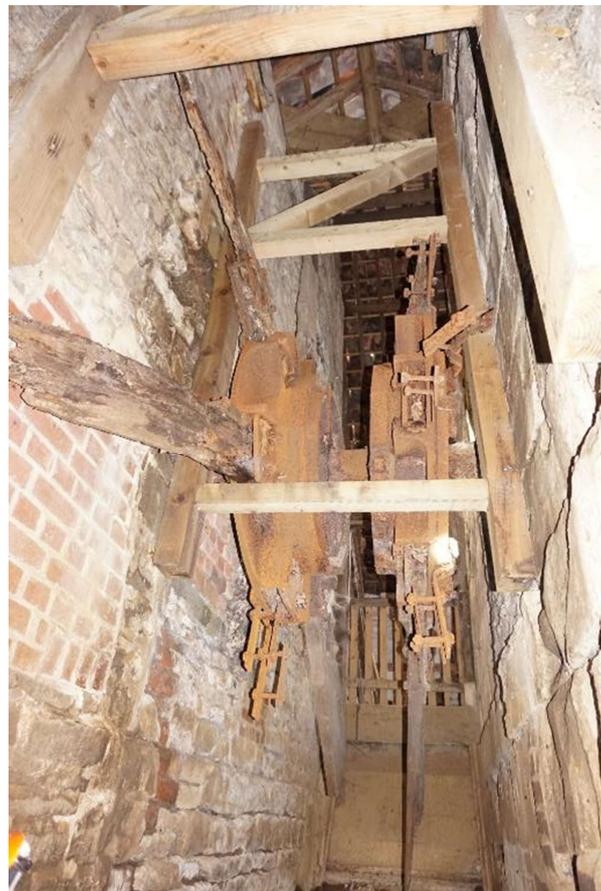
Figure 13 Downstream Watercourse W1 – Upper Reach

Derelict Waterwheel -Watercourse W1

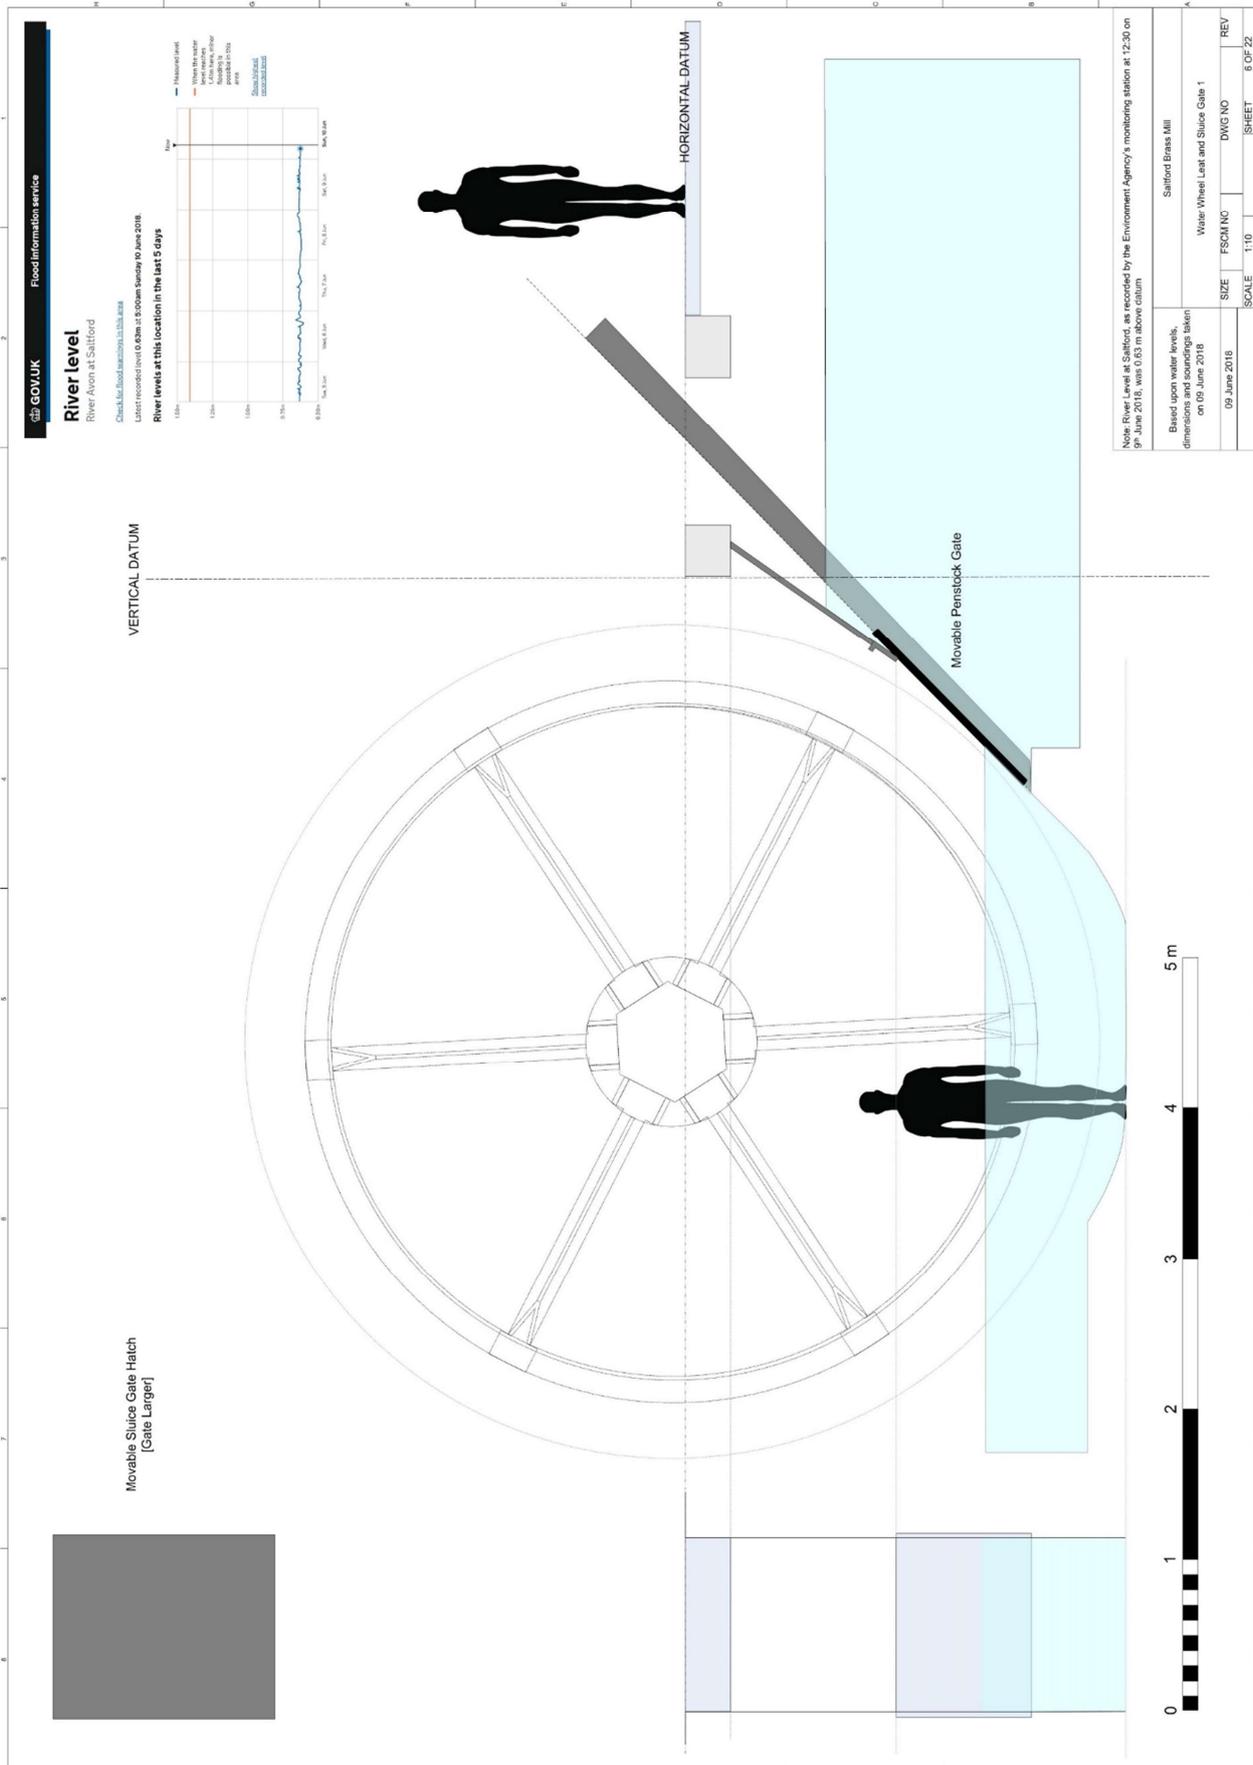
Figure 14 Penstock Gate W1

Penstock-gate W1 [Figure 14] comprises a lower moveable gate and upper fixed shutter. The fixed shutter is made from wrought-iron, set in a wrought-iron channel mounted at 35° to the vertical, itself set into a section of the culvert wall constructed from ashlar masonry.

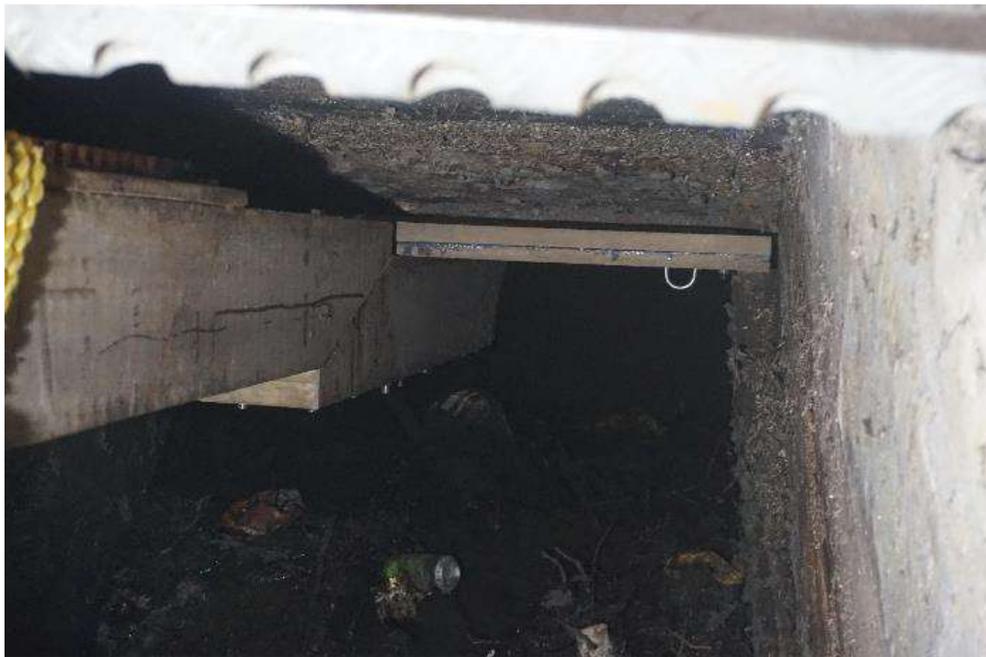
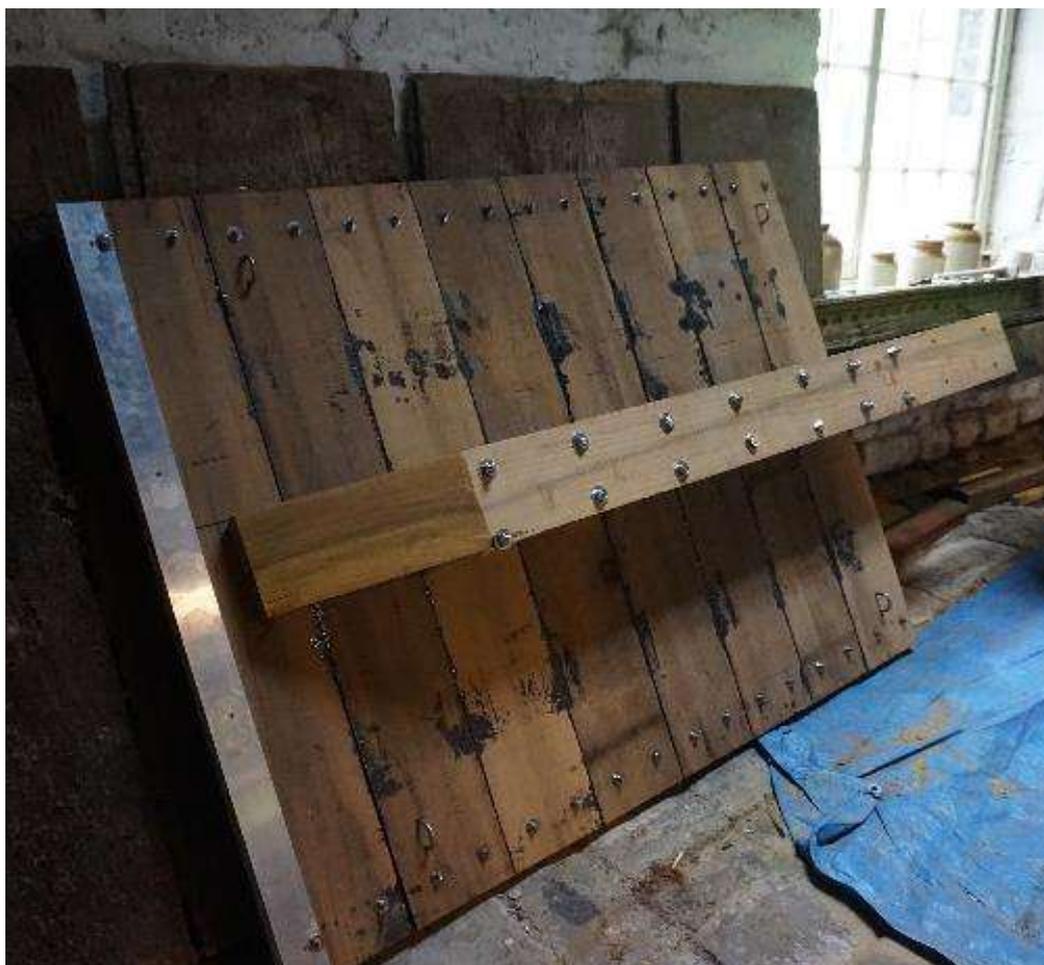
Figure 21 New Penstock Gate W1

New gate – Scarf Joint and Laminated Gate

New Gate and Lower Stock

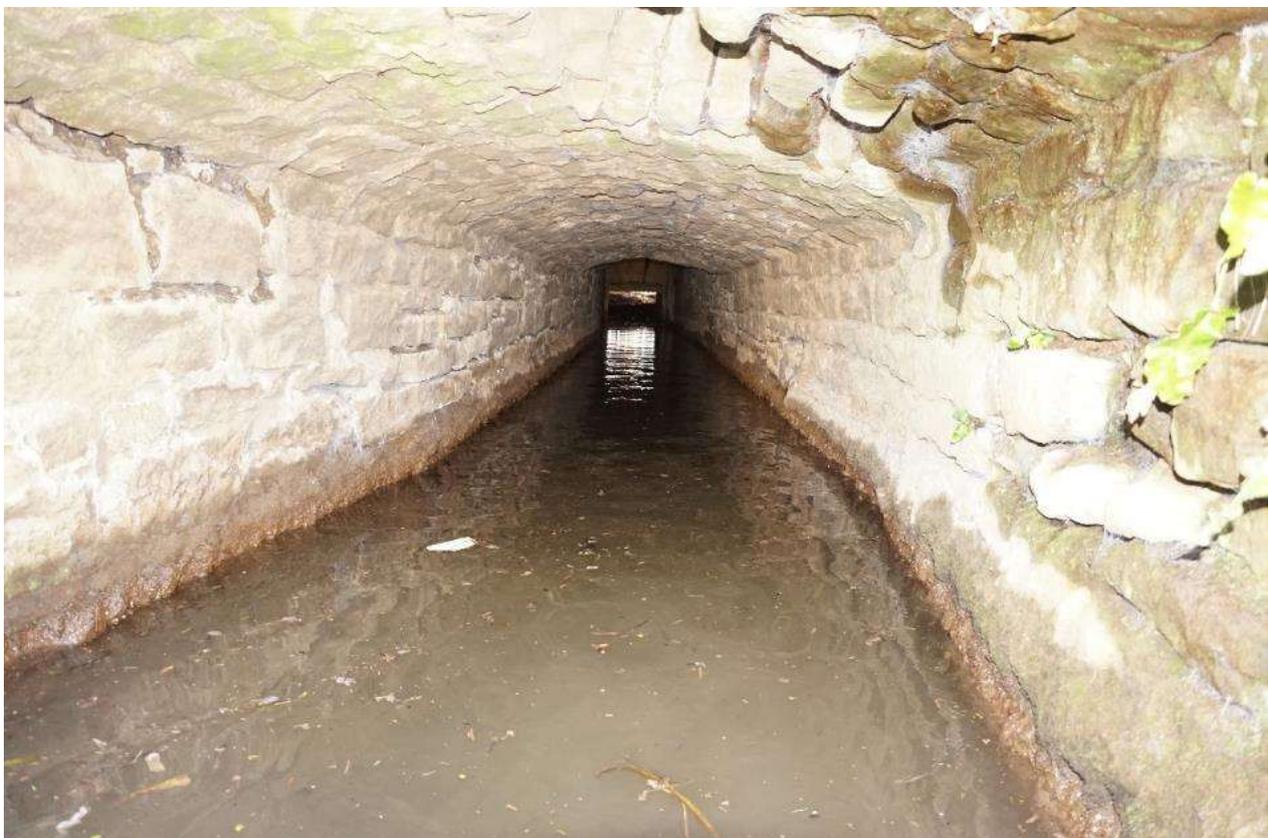
Figure 22 Watercourse W1 – Lower Reach

The downstream culvert is only lightly silted; flow through the damaged penstock-gate having purged the lead. The walls and roof of the culvert appear in good condition and there is no evidence of structural instability. There is a general need for repointing throughout the culvert and some masonry is loose, but not to the extent of structural instability. The downstream lead can be accessed when the river is low; however, the re-pointing programme would benefit from de-watering of the downstream lead to enable the lower-walls to be re-pointed as well as the higher-walls.

View looking upstream from the Culvert Outlet

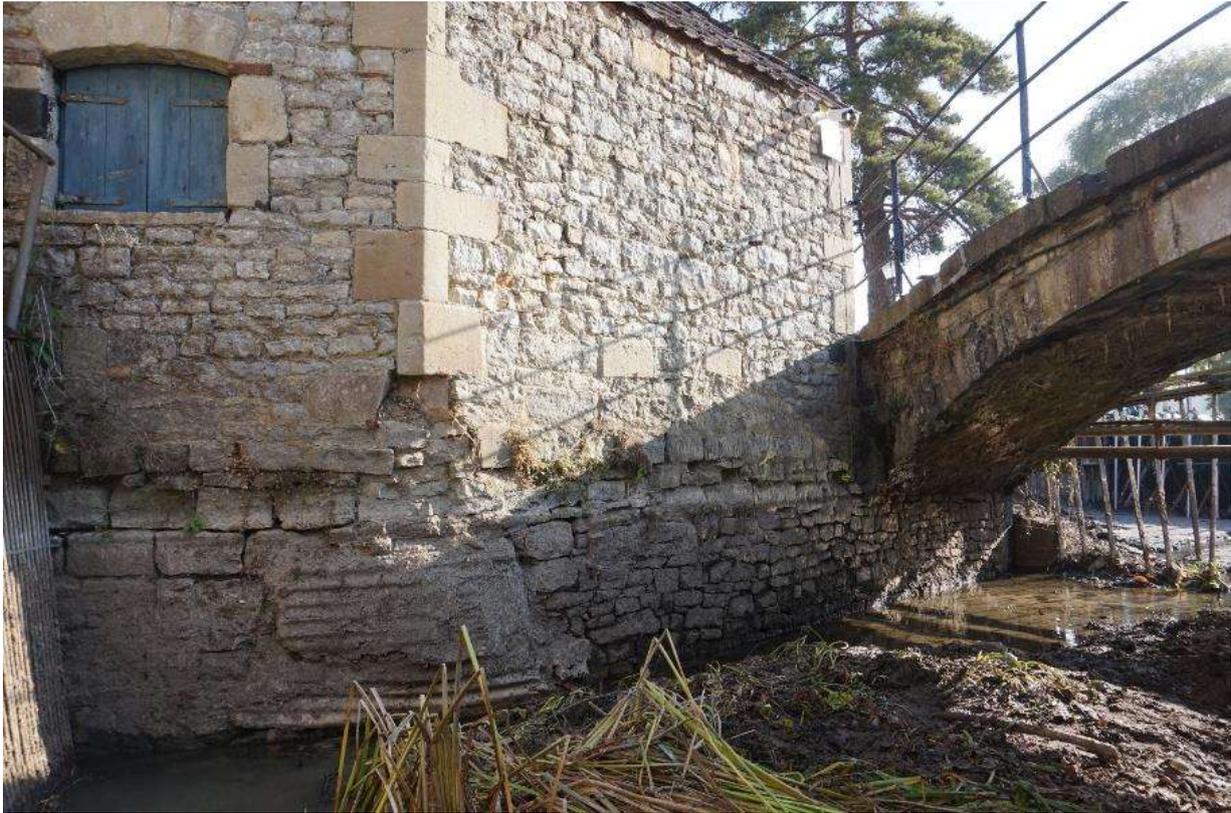
Figure 24 Watercourse W1/W2 Tail-Race

The walls of the W1/W2 tail-race leat are constructed from a combination of well-cut ashlar and cast copper-slag blocks [Figure 24] indicating that they are of eighteenth-century construction, laid after the mill was leased by the Bristol Brass Company in 1721.

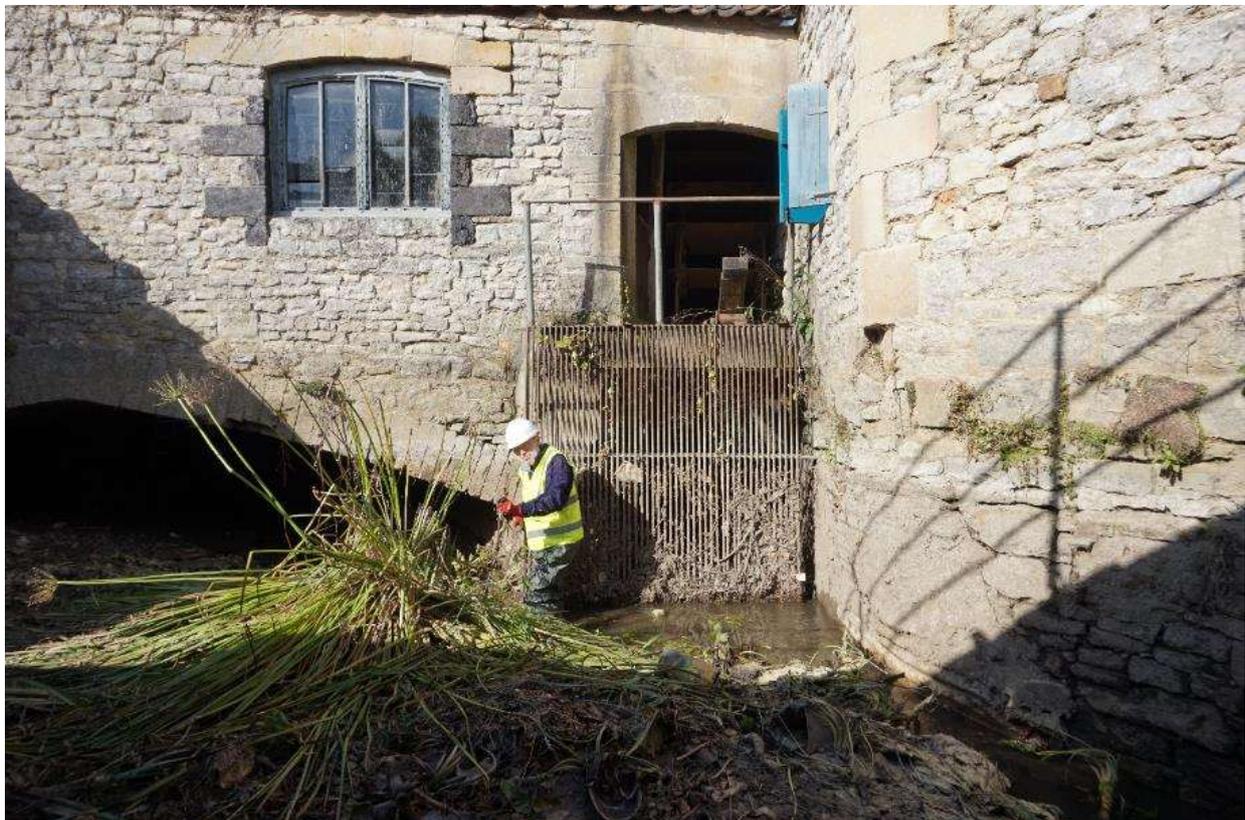
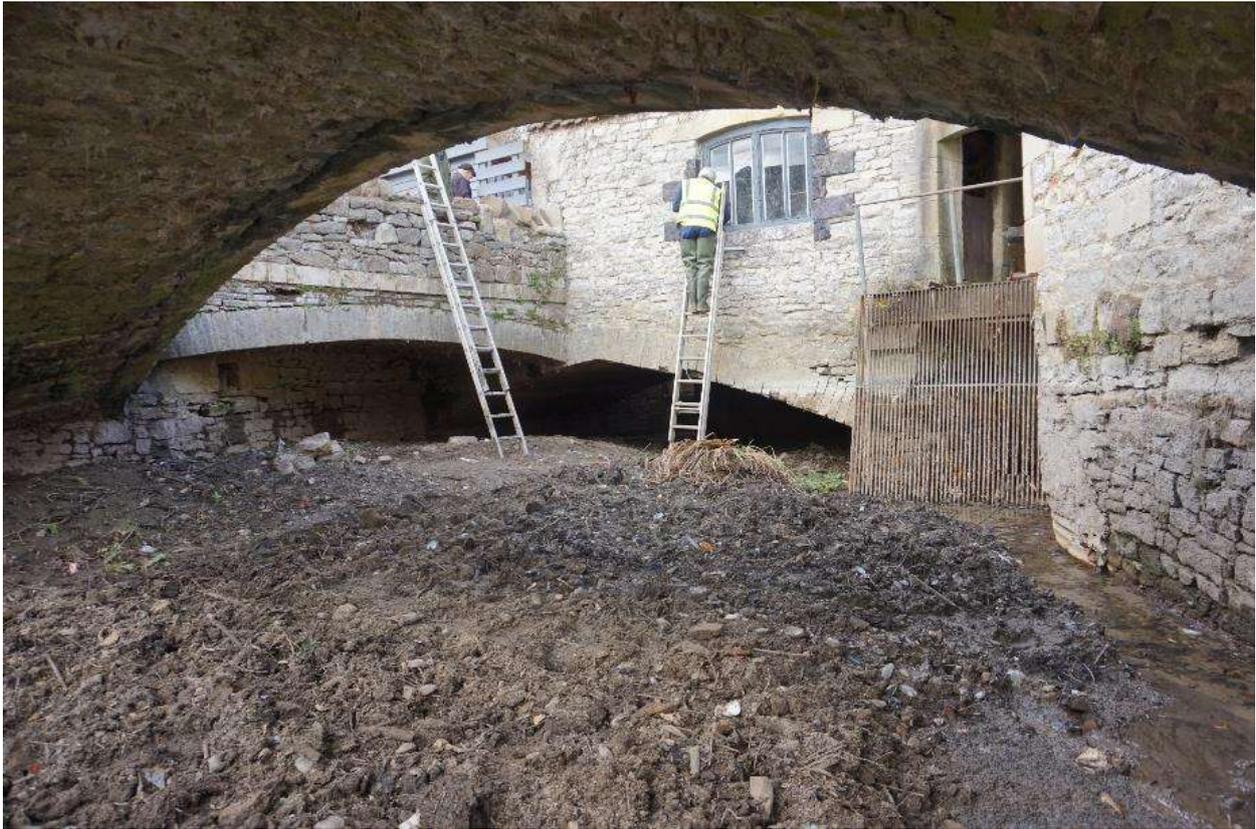
Figure 25 Head Race - Watercourse W2, W3 & W4

An area of open water exists between the road bridge and southern wall of the mill which is the head race for watercourses W2, W3 and W4 (Figure 25 and Figure 26). The boundaries of the open water are: the road bridge; the west-wall of the upper rolling mill; penstock W2; and a chamber beneath the area now-known as the dynamo room from which watercourses W3 and W4 are fed.

the head race performs a number of functions: it is the foundation for the west-wall of the rolling mill; it becomes the western-pier of the road bridge; and it is contoured to direct flow into watercourse W2 (Figure 25). The wall is constructed from a combination of roughly-coursed local rubble stone with lime mortar binding and larger blocks of well-coursed local stone where structural integrity is important, principally at the base of the mill superstructure and around the entrance to watercourse W2.

Exterior wall of upper rolling mill, mill watercourses, road bridge and western pier

Exterior wall of upper rolling mill and southern wall of dynamo room

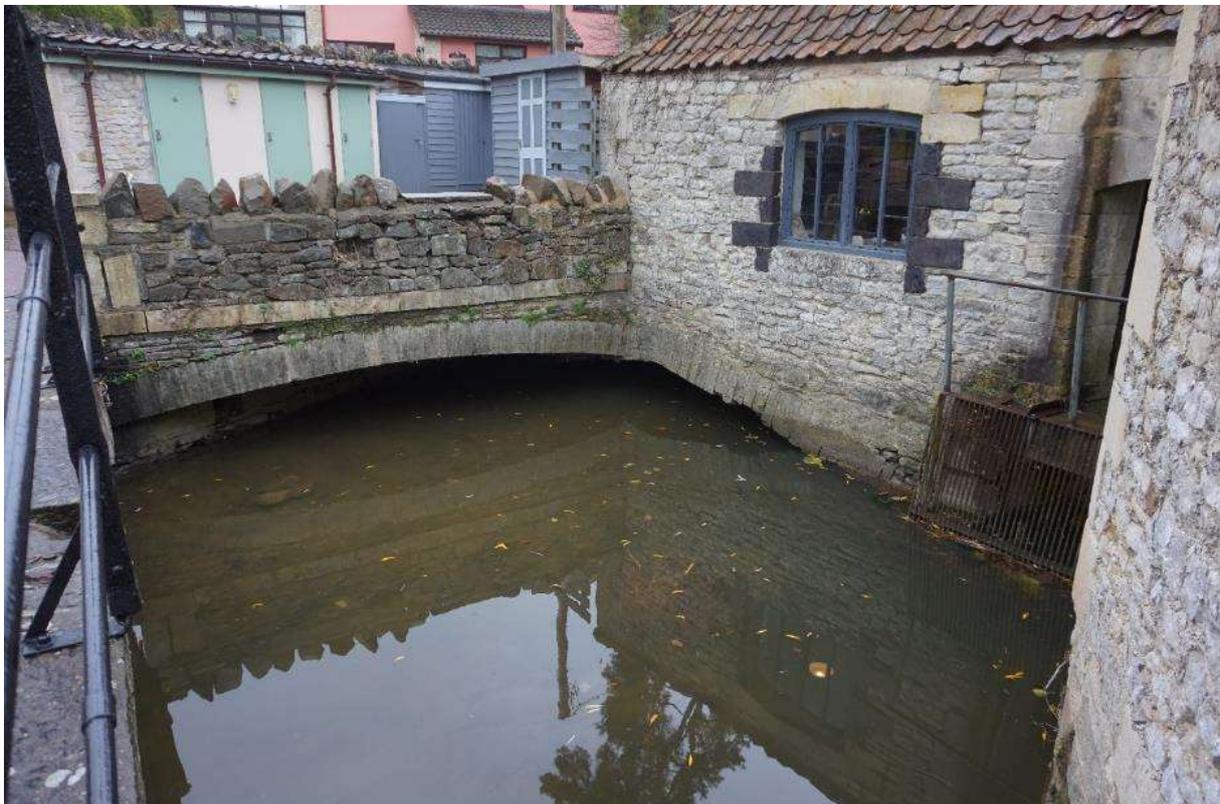
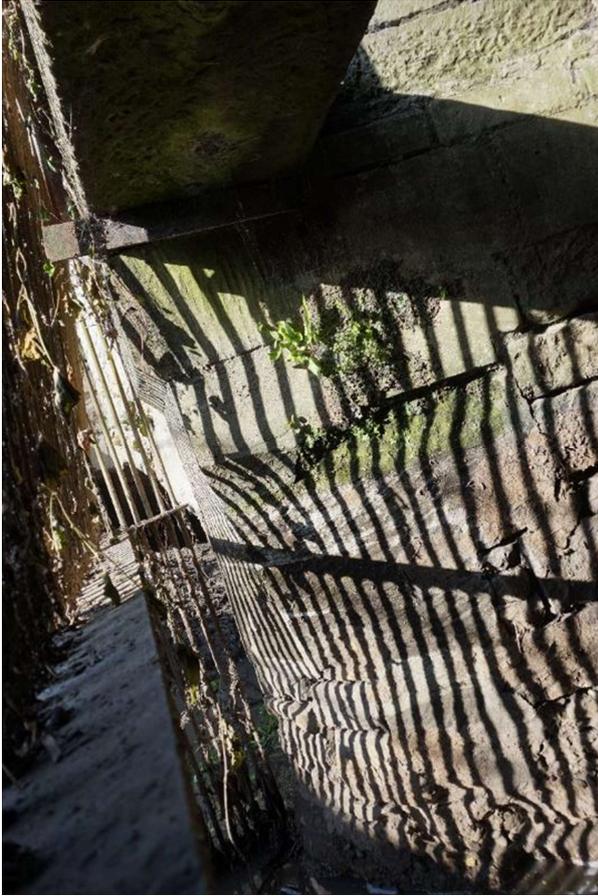
Figure 26 Watercourse W3/W4 Head Race

W3/W4 western Chamber and Watercourse 02 inlet

W3/W4 Western Chamber - Flooded

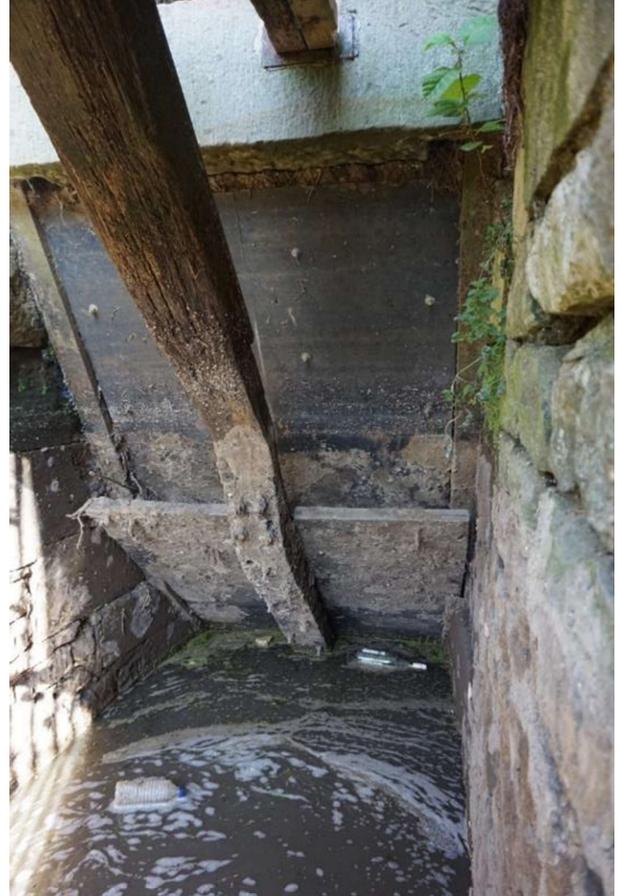
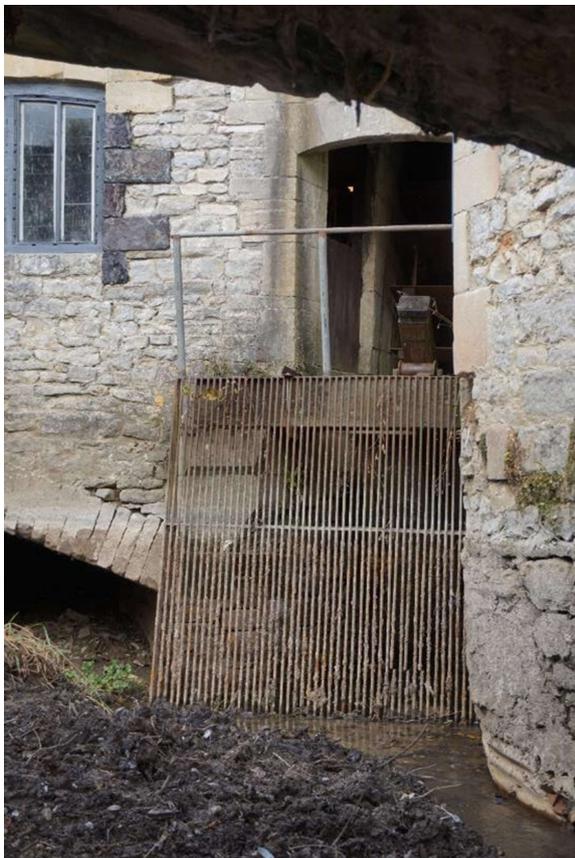
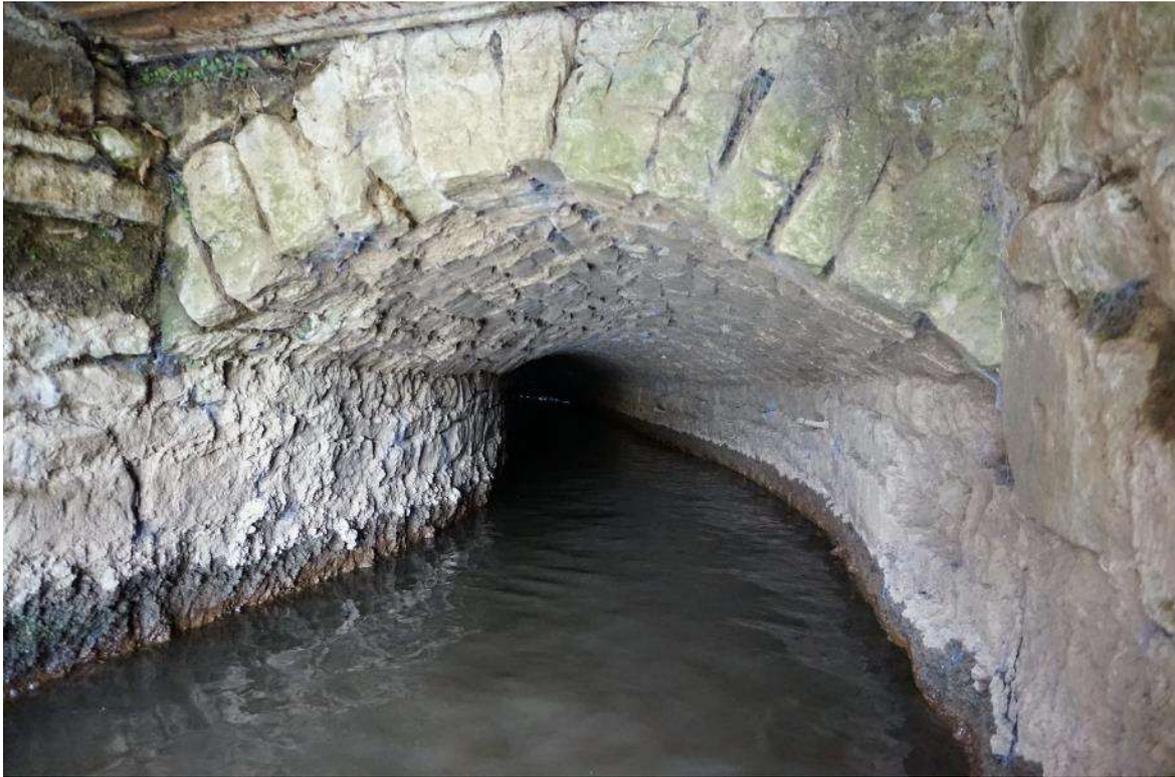
Figure 27 Watercourse W2 – Inlet

long [Figure 27], creating a funnel at the entrance to the penstock.

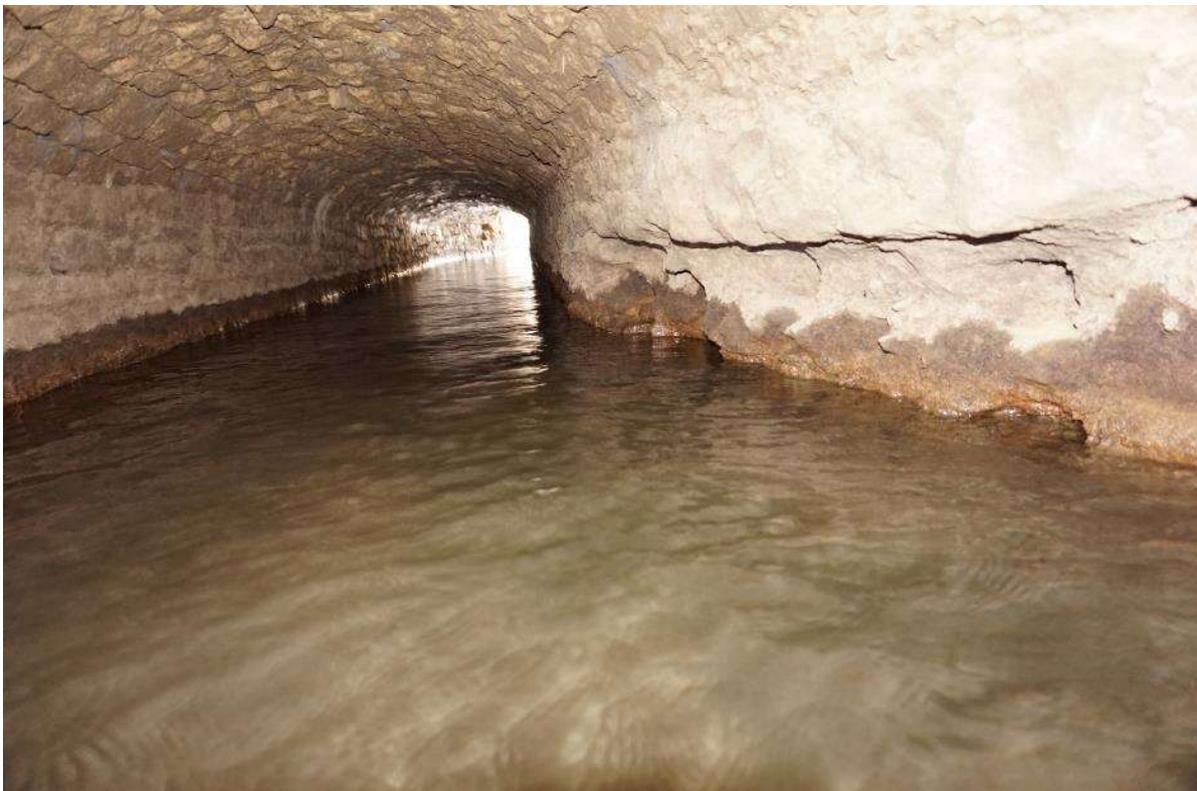
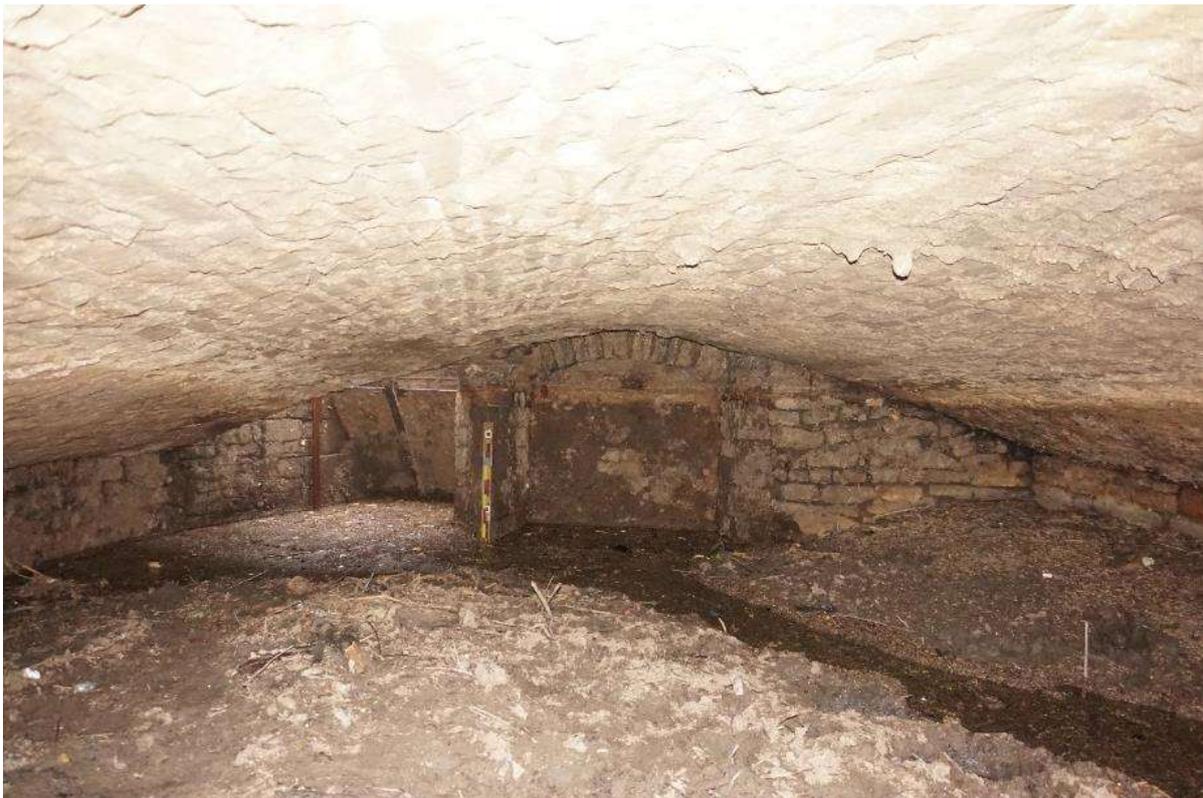
Figure 29 Watercourse W2

Tail-Race Culvert W2 is generally in good condition, although there is an area of damage on the eastern wall of the culvert, beneath the southern wall of the squash-court. The damage extends for approx. 2.5m along the waterline and is 2-3 courses high [Figure 29]. The surface layers of stone have fallen but the rear layers of stone remain in place and are stable. Overall, the culvert is stable and there is no evidence that it is in danger of collapse. The stonework would however benefit from repointing. This will ideally require de-watering of the downstream watercourses to enable repointing to the base of the walls.

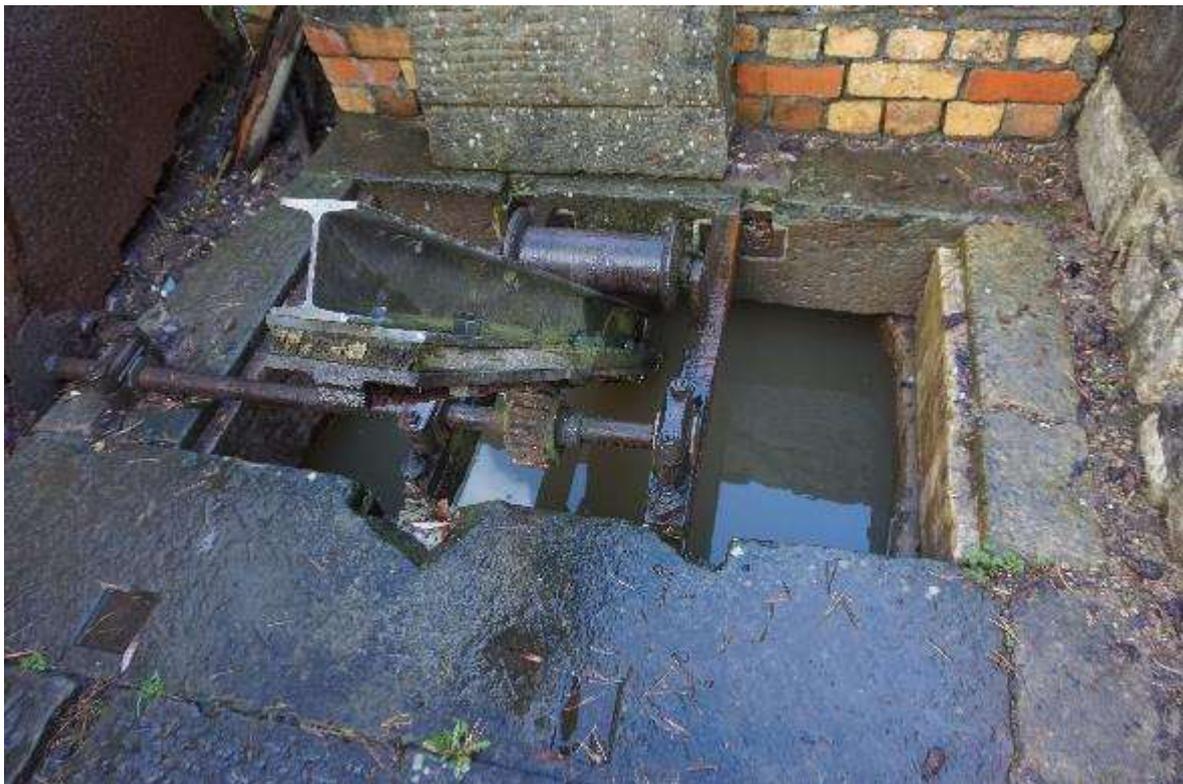
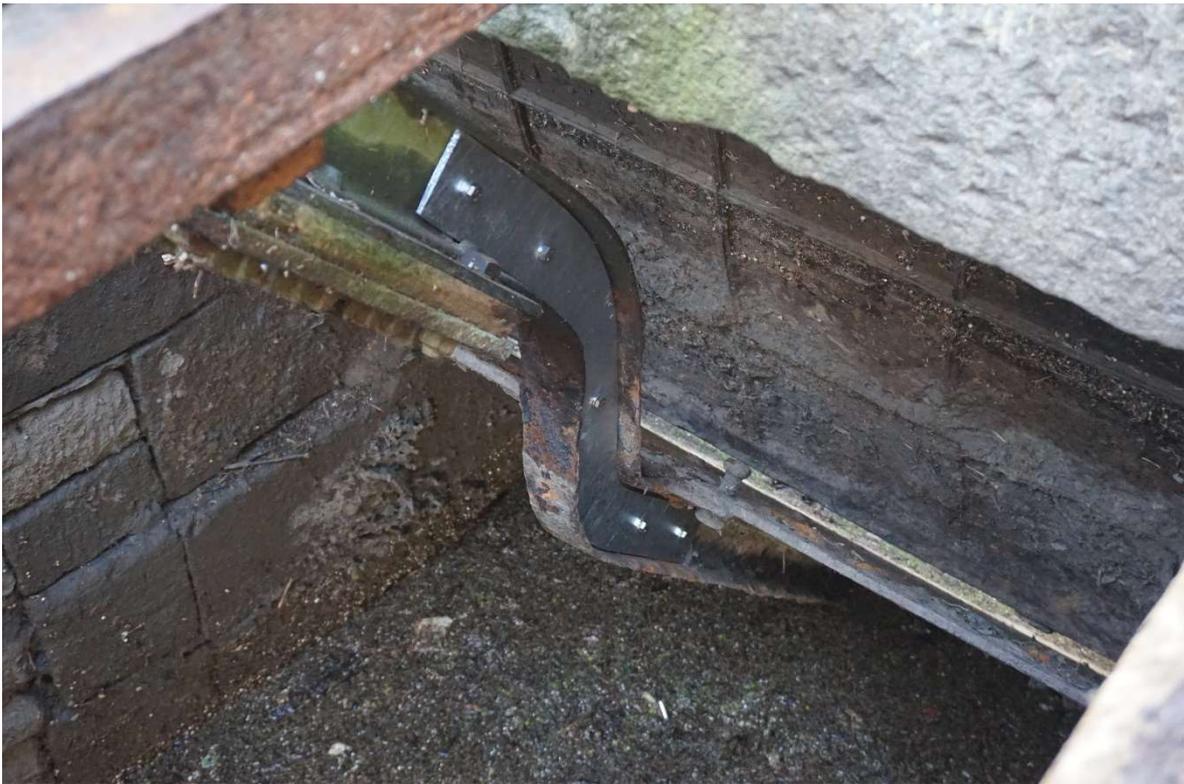
Figure 35 Penstock Gate W4

Penstock-gate W4 [Figure 35] is fabricated from iron and steel, having an iron lifting gate, iron fixed shuttering and a steel stock. The operating mechanism and iron guide-rails are of similar design and dimensions to the penstocks W1 and W2 suggesting that the assembly was originally made of wood. There are no records of the penstock being modified; hence the current gate could date from the 1960s, the 1920s (when Eric Butler adapted the mill to become a sports centre) or the 1880s (when attempts were made to modernise the brass mill).
