Salford Brass Mill

Watercourse Inspection and Penstock Repair

Survey Report

January 2019

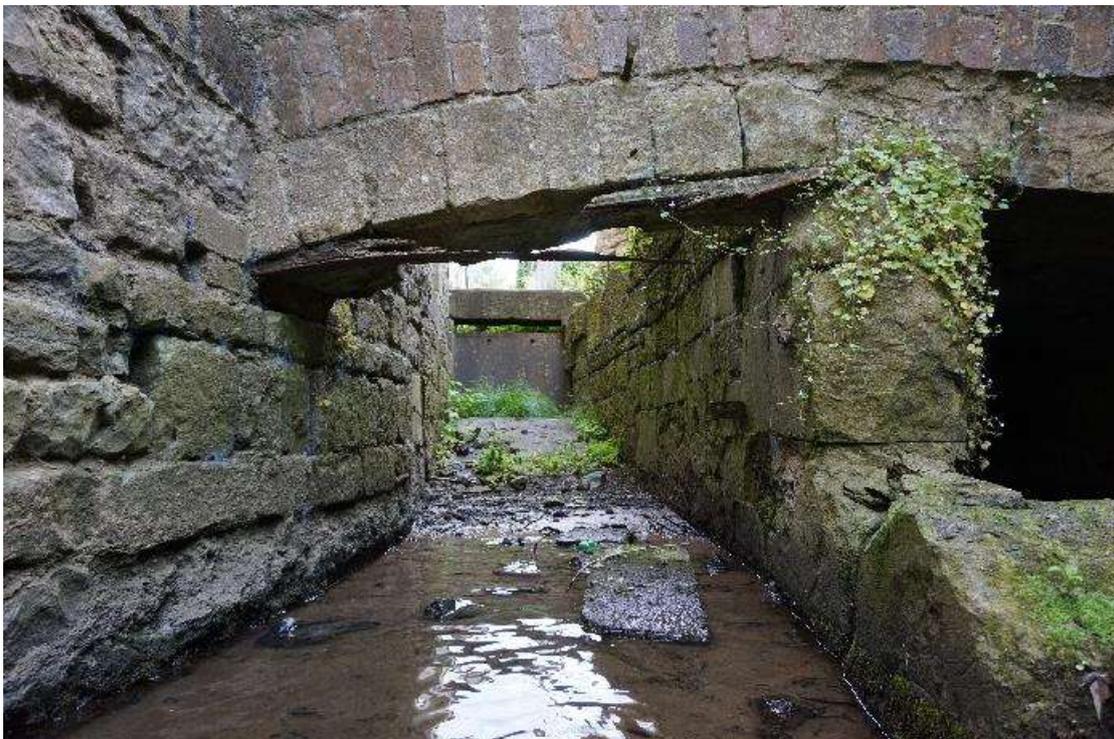
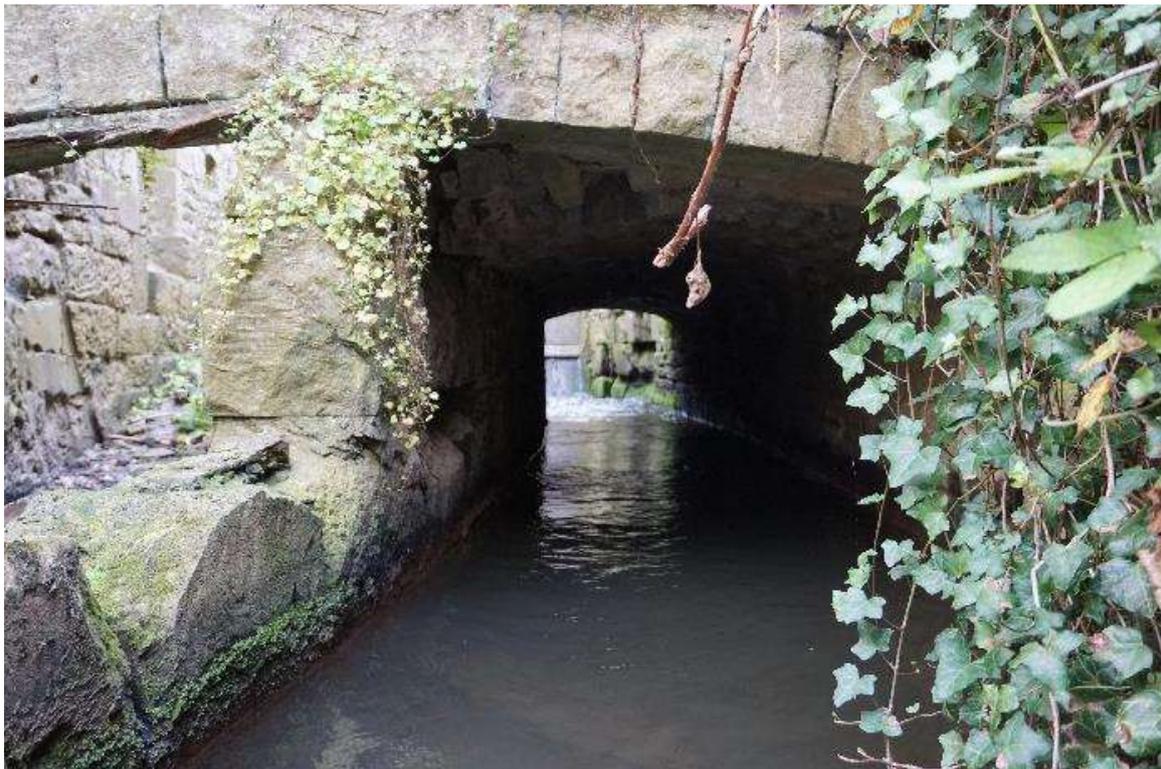
Figure 37 W3/W4 Tail Race Leat

Watercourses W3 and W4 discharge into a common tail-race which continues north-east to re-join the river [Figure 37, Figure 38 and Figure 39]. The walls of the leats are constructed from a combination of local rubble stone, ashlar stone and cast copper-slag blocks. The west wall holds back the river bank which is approx. 3.0m high.
